2011 GREAT EAST JAPAN (TOHOKU) EARTHQUAKE & TSUNAMI

Earthquake Reconnaissance **OBSERVATIONS**

JUNE 2011

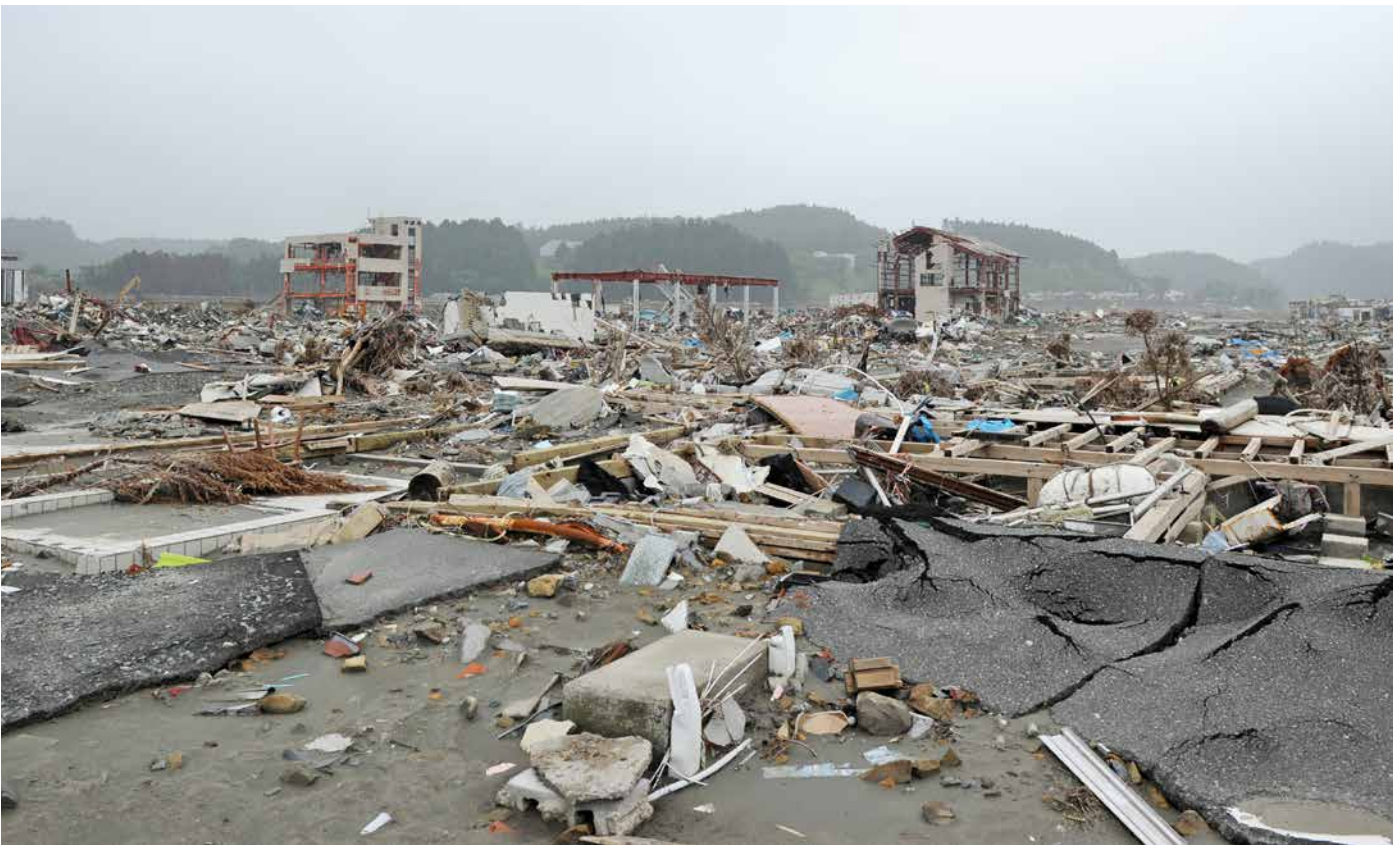
FIGURE 2 - Tsunami Damage in Minami Sauriku, Japan (Swanson)

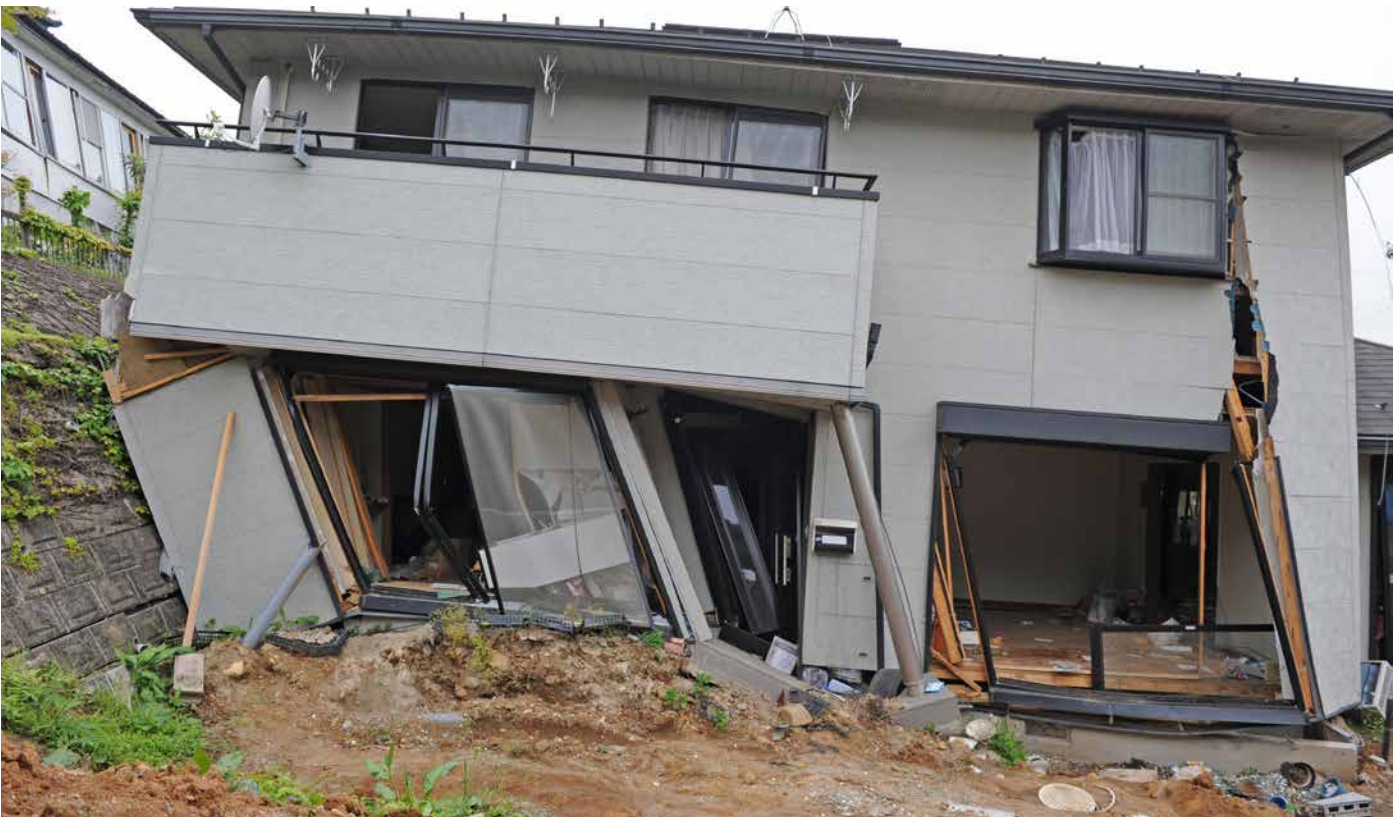
FIGURE 3 - Residential Building Collapse from large areal landslide beneath a residential neighborhood in Sendai City, Aoba Ward (Swanson)

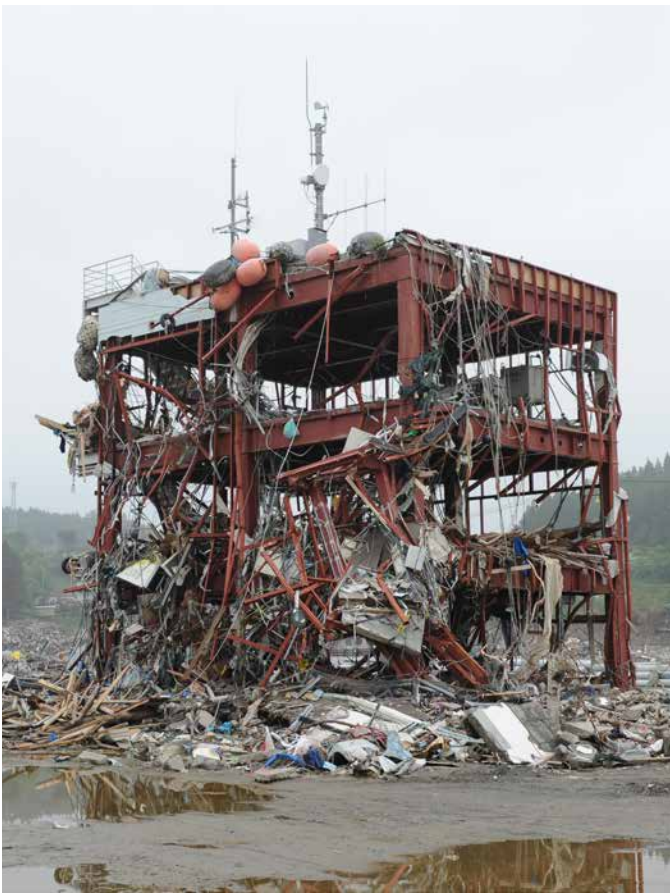
FIGURE 4 - Modern Disaster Prevention Center building in Minami Sauriku after the 14m high tsunami (Swanson)

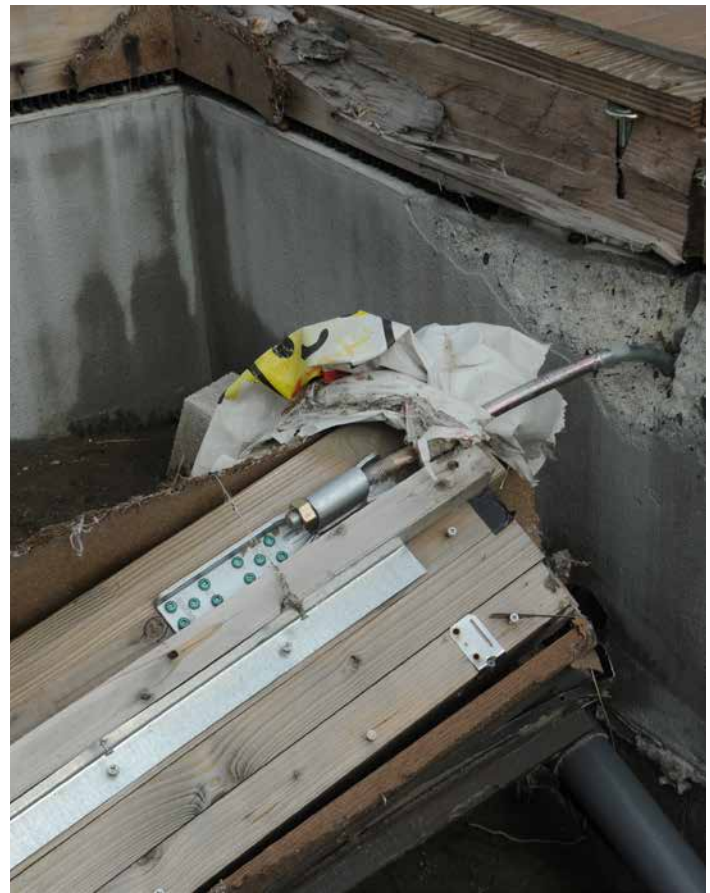
FIGURE 5 - Bent Wood-framed Shear Wall Hold-Down Connection from Tsunami (Swanson)

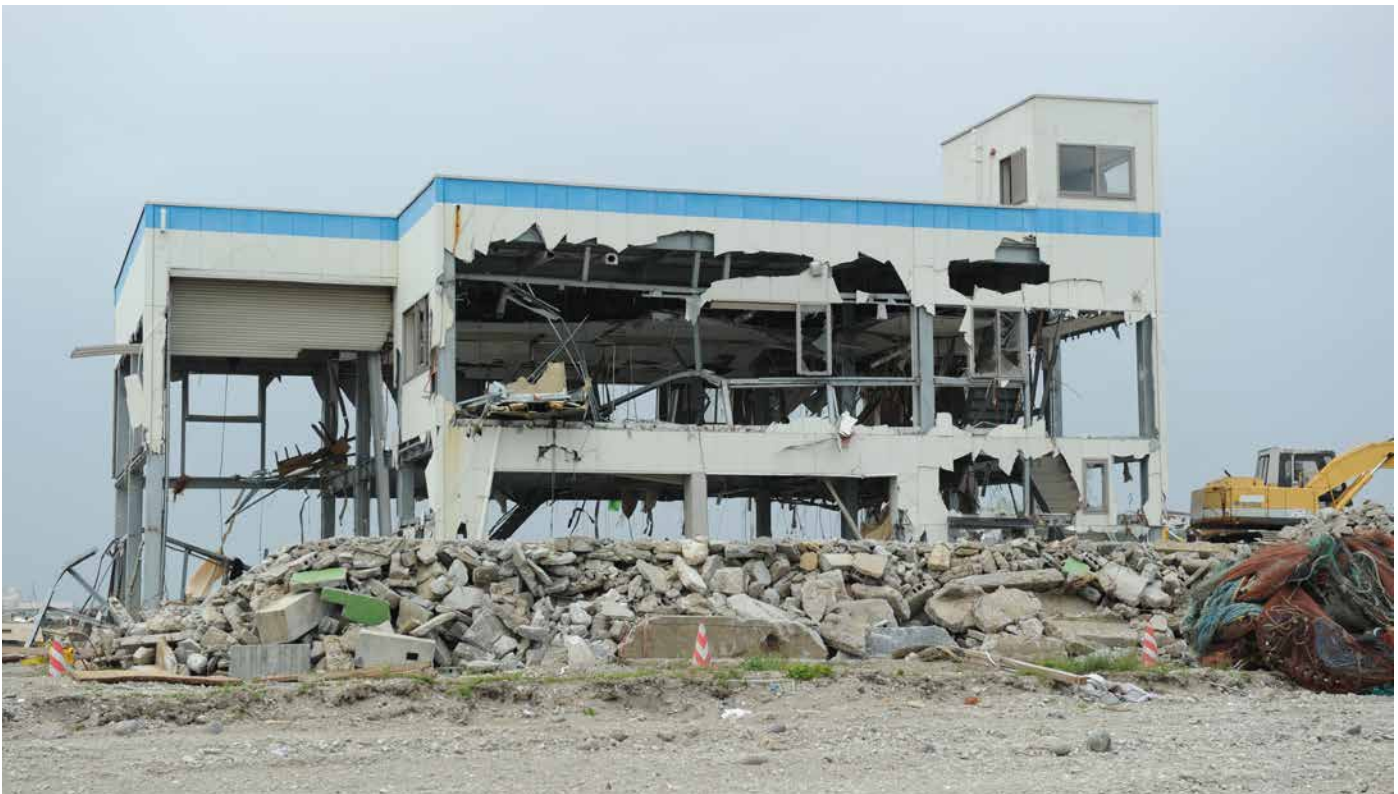
FIGURE 6 - Tsunami Damaged Steel Moment Frame Building in Natori from 7m Tsunami Height (Swanson)

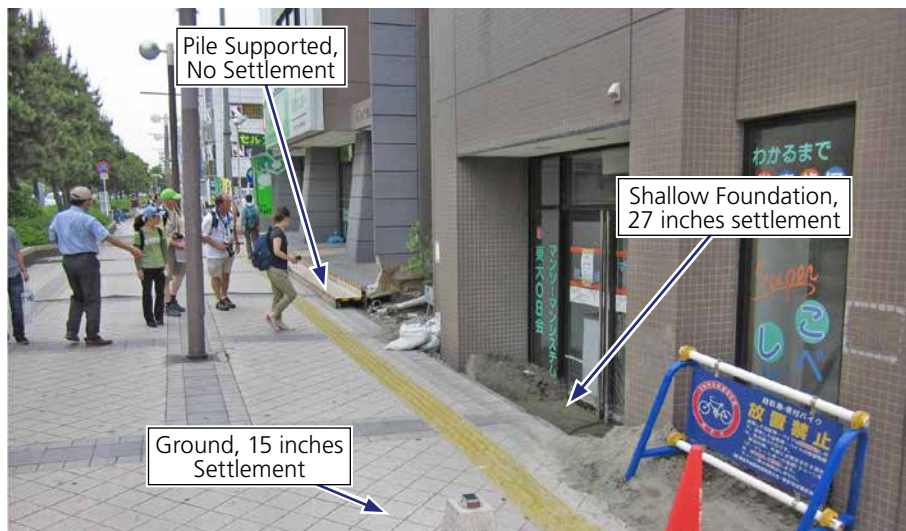
FIGURE 8 - Performance difference between adjacent buildings supported on piles versus shallow foundations in Urayasu City (Lindquist)

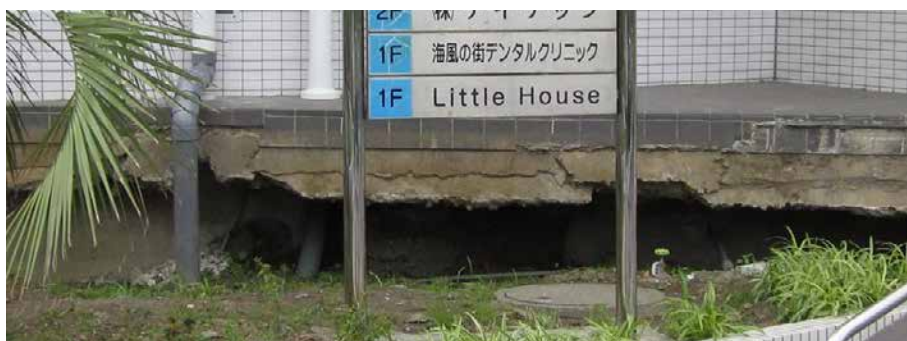
FIGURE 9 - Temporary utility connection following settlement caused by liquefaction in Urayasu City (Lindquist)

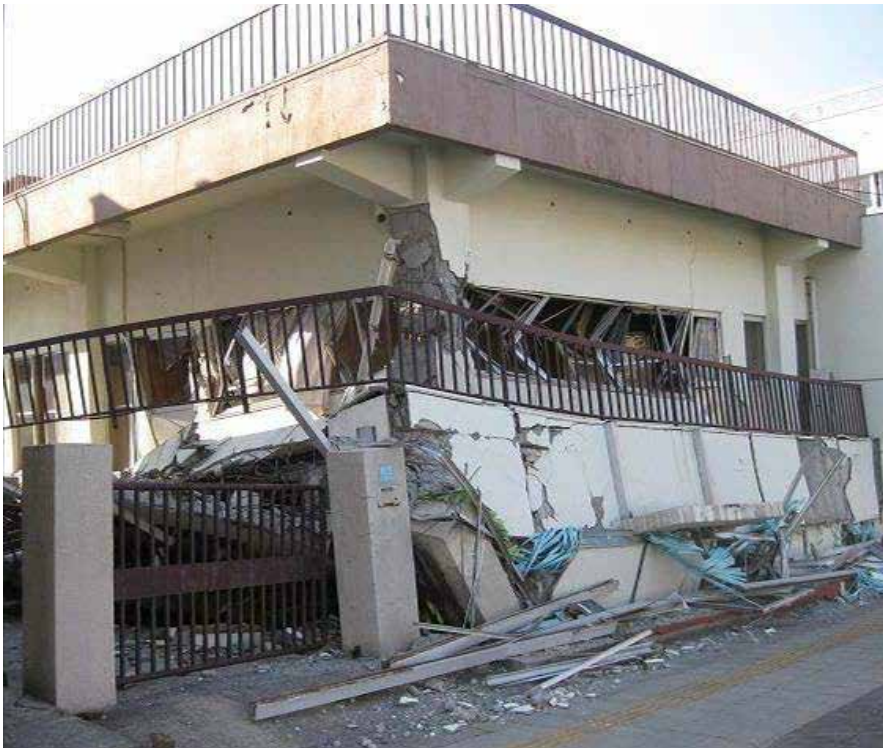
FIGURE 10 - Non-ductile concrete frame-over shear wall building. First-story walls failed in out-of-plane direction, Second-story columns failed in shear. (image courtesy of Motosaka)

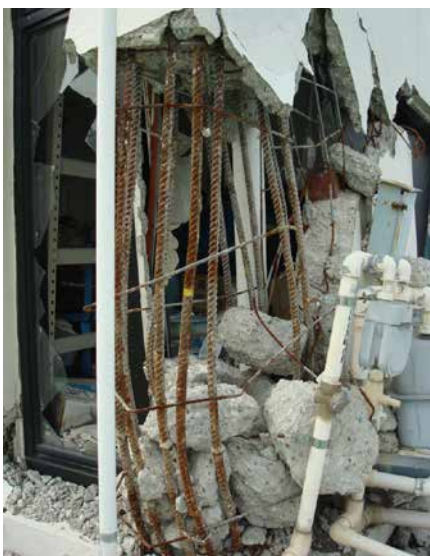
FIGURE 11 - Non-ductile shear wall boundary member detailing at a penthouse on top of a nine-story concrete building with a two-story podium. (Siu)

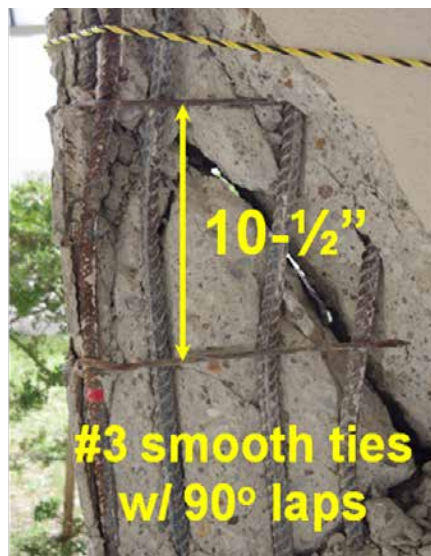
FIGURE 12 - Non-ductile concrete column detailing at the first story of a two-story building located in an area with potential topographic effects. (Siu)

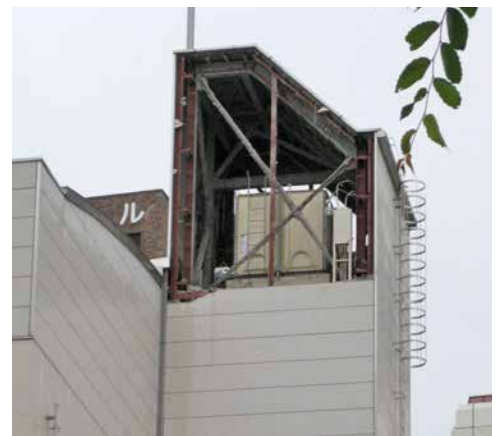
FIGURE 14 - Cladding damage at a school in Sendai. (Siu)

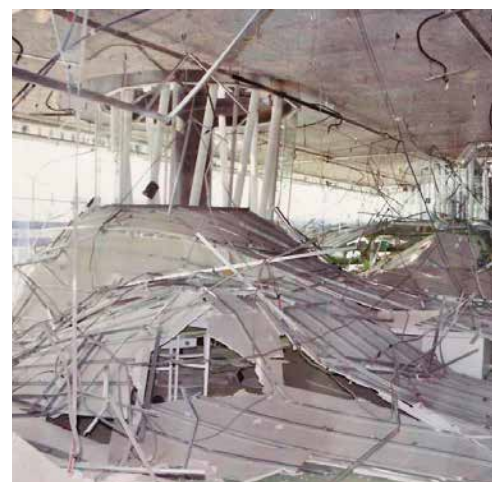
FIGURE 15 - Unbraced suspended ceiling collapse at the Sendai Mediatheque. (Siu)

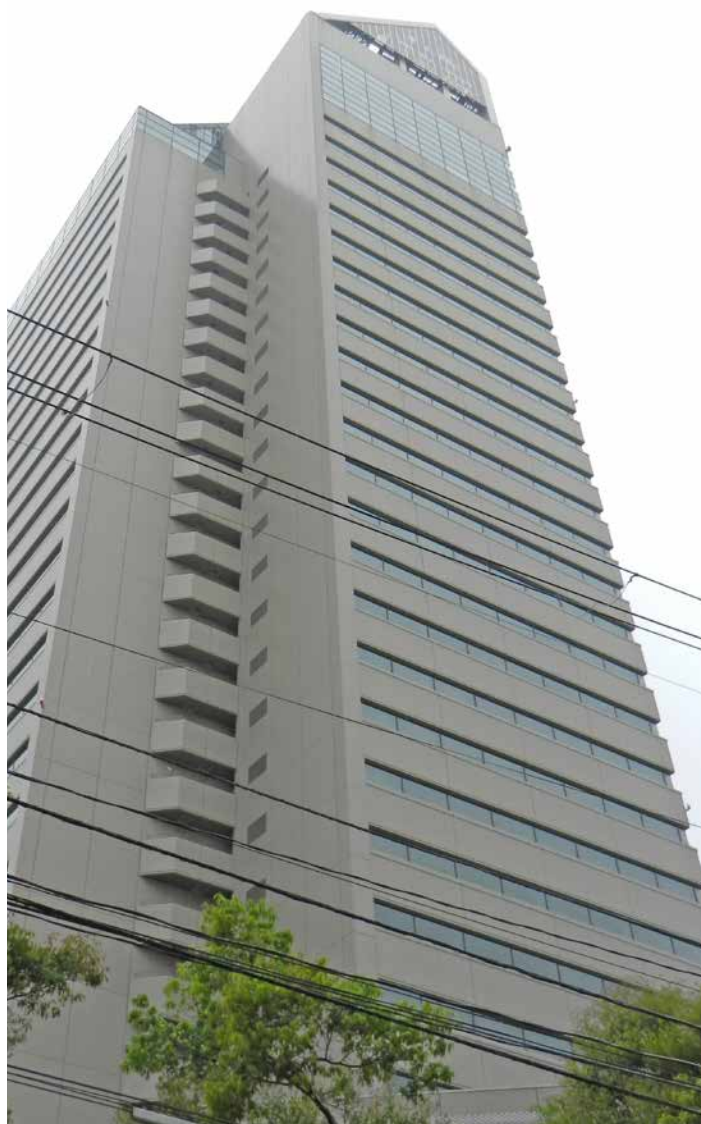
FIGURE 16 - High-rise building in Sendai. No structural damage was reported, but businesses and equipment on the top floors were damaged. (Taylor)

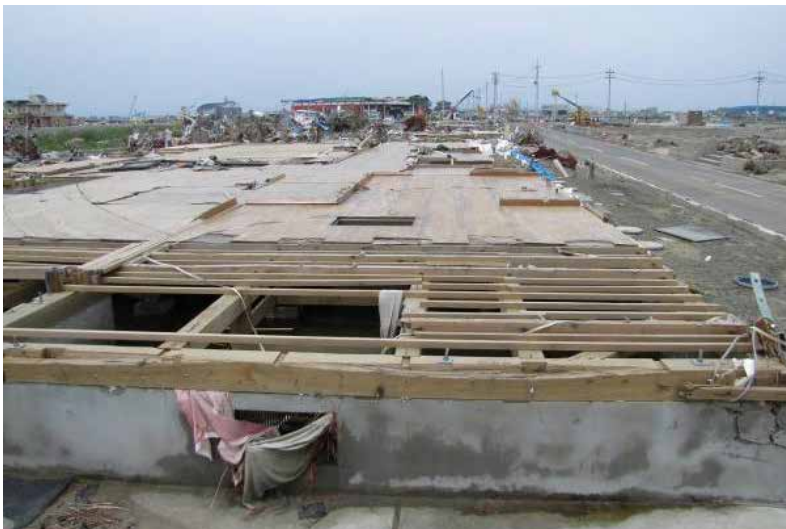
FIGURE 24 - Destroyed wood-framed buildings in Arahama Ward (Sendai). (Pierepiekarz)

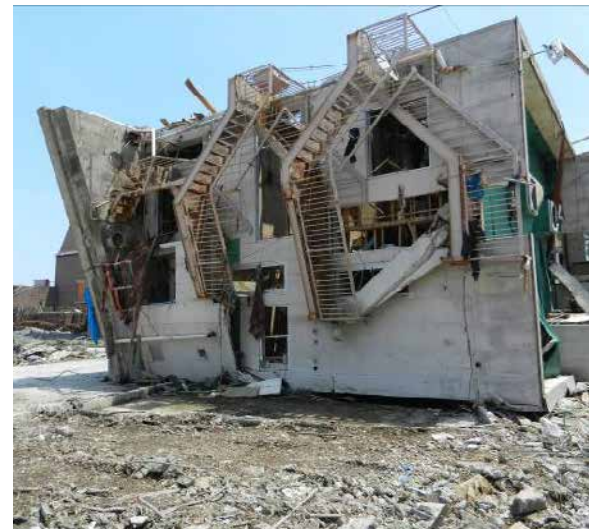
FIGURE 25 - Overturned steel-framed structure in Onagawa City. (Taylor)

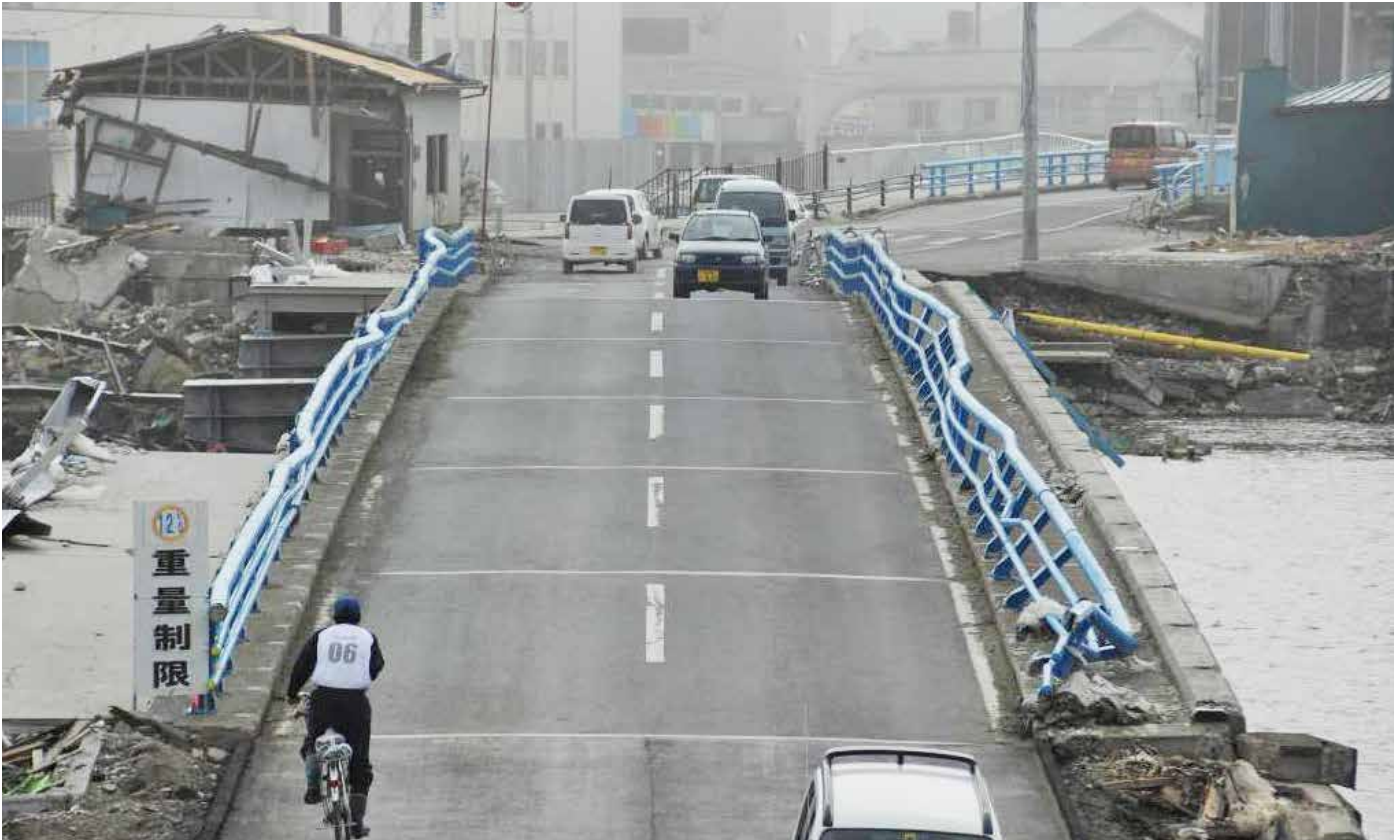
FIGURE 26 - Functional Low-Profile Vehicle Bridge In Ishinomaki City. Note Damage from Tsunami to Leading Edge of Bridge Walkway and Guardrail on the left side of the photo. (Swanson)

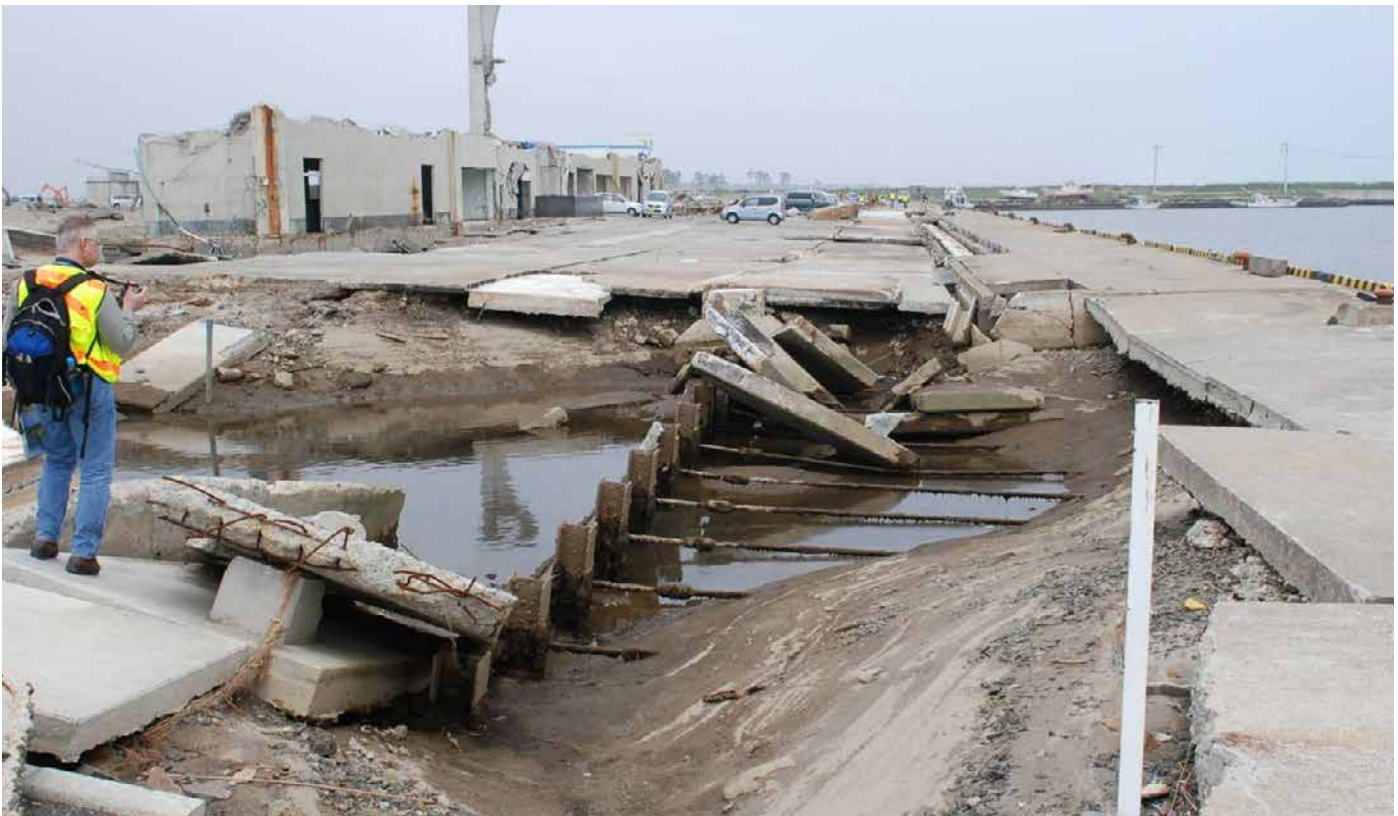
FIGURE 27 - Waterfront Tsunami Scour Behind Seawall in Yuriage. Note Exposed Seawall Tiebacks. (Swanson)

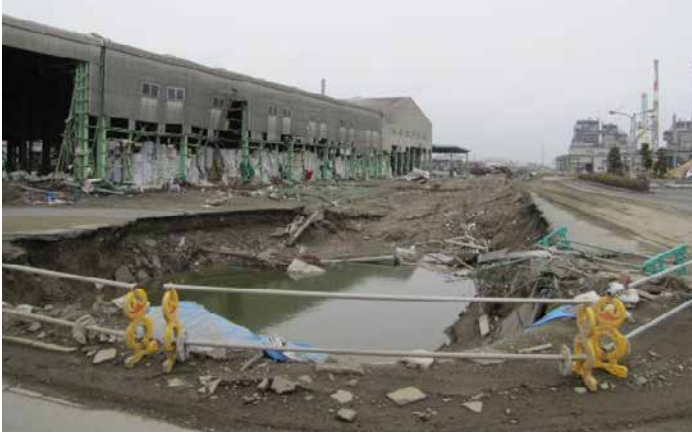
FIGURE 28 - Ishinomaki City – tsunami impacts to warehouses and infrastructure. (Pierepiekarz)

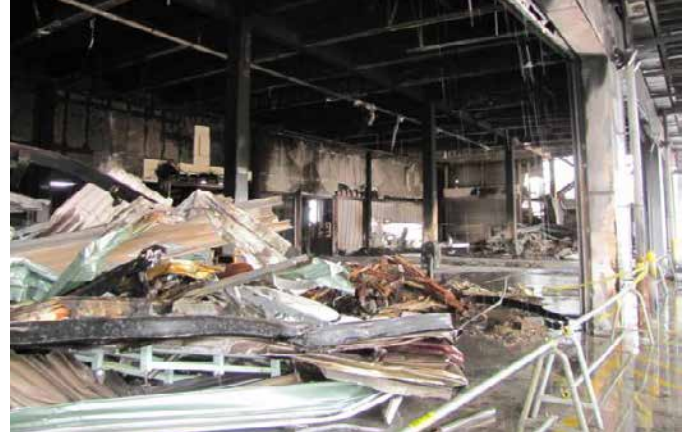
FIGURE 29 - Fire-following-earthquake impacts at Sendai Airport cargo area. (Pierepiekarz)

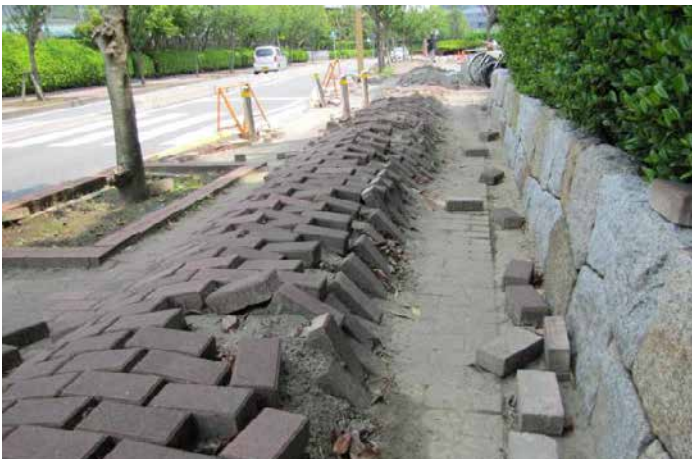
FIGURE 30 - Underground utility impacts (soil liquefaction) in Chiba (Tokyo metro) area. (Pierepiekarz)

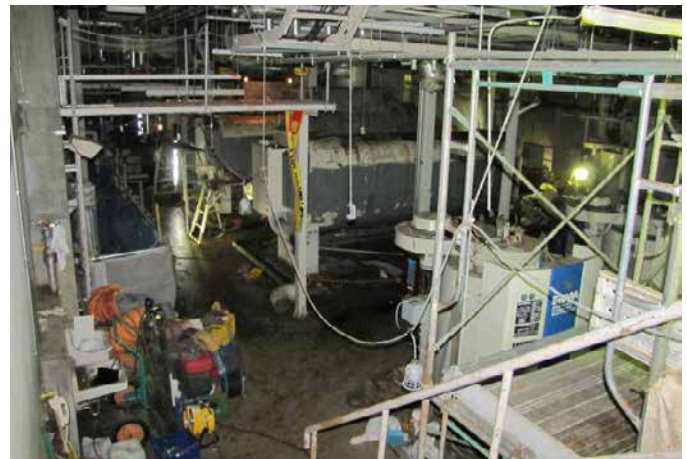
FIGURE 31 - Sendai Airport – main utility room located below grade was flooded. (Pierepiekarz)

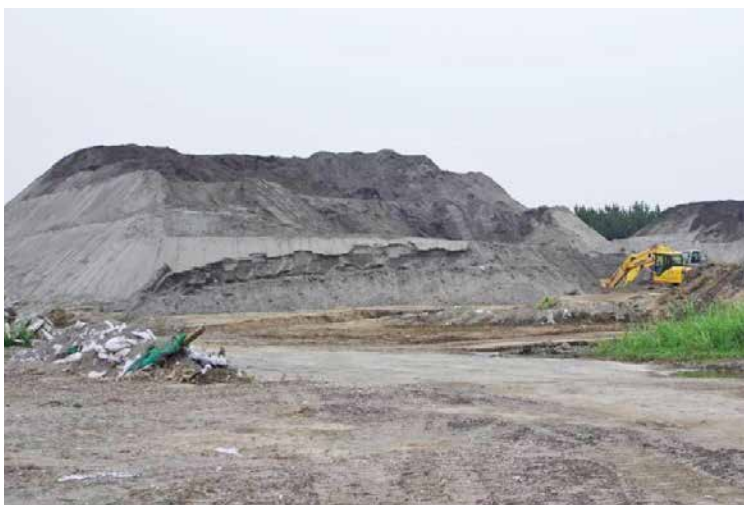
FIGURE 37 - One of three mountains of liquefaction sand in Urayasu City. Liquefaction ejecta totaled over 80,000 m³. (Siu)
