2017 CENTRAL MEXICO EARTHQUAKE RECONNAISSANCE REPORT

On September 19, 2017, at 1:14 p.m. (local time) exactly 32 years to the day after the tragic M8.0 1985 earthquake, central Mexico was struck by a M7.1¹ intraplate earthquake (Fig. 1). It struck only two hours after a citywide earthquake drill and put a dramatic end to commemoration activities taking place throughout the city. This was the second earthquake in a matter of weeks – an M8.1 earthquake located in the Chiapas Region, approximately 467 miles from Mexico City, had struck on September 7. As a result of normal faulting at

Earthquake Reconnaissance Overview

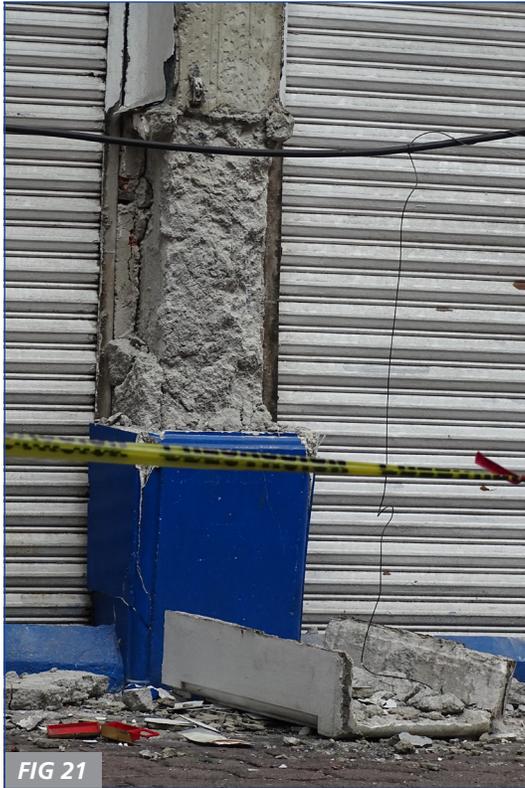
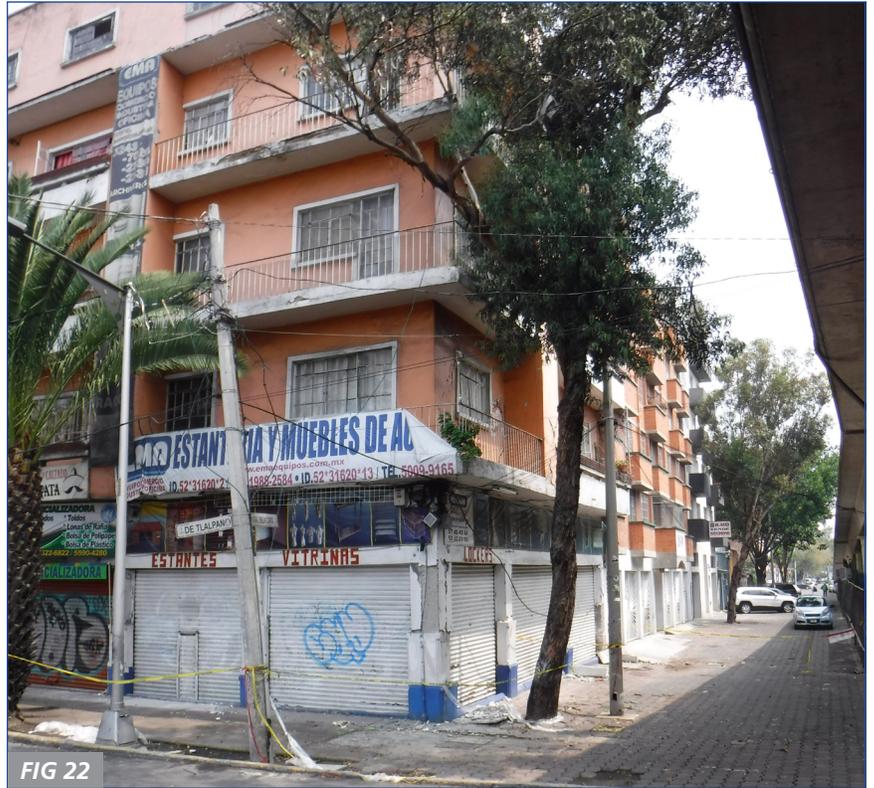
FIG 21

DAMAGED URBAN BUILDING IN BENITO JUAREZ - 5-story structure that had columns at the first floor, which appeared to be sheared through the middle of the span. This would indicate that the building may be on the brink of collapse. A soft-story irregularity, generally where a floor is considerably less stiff than the ones above, is likely the cause.

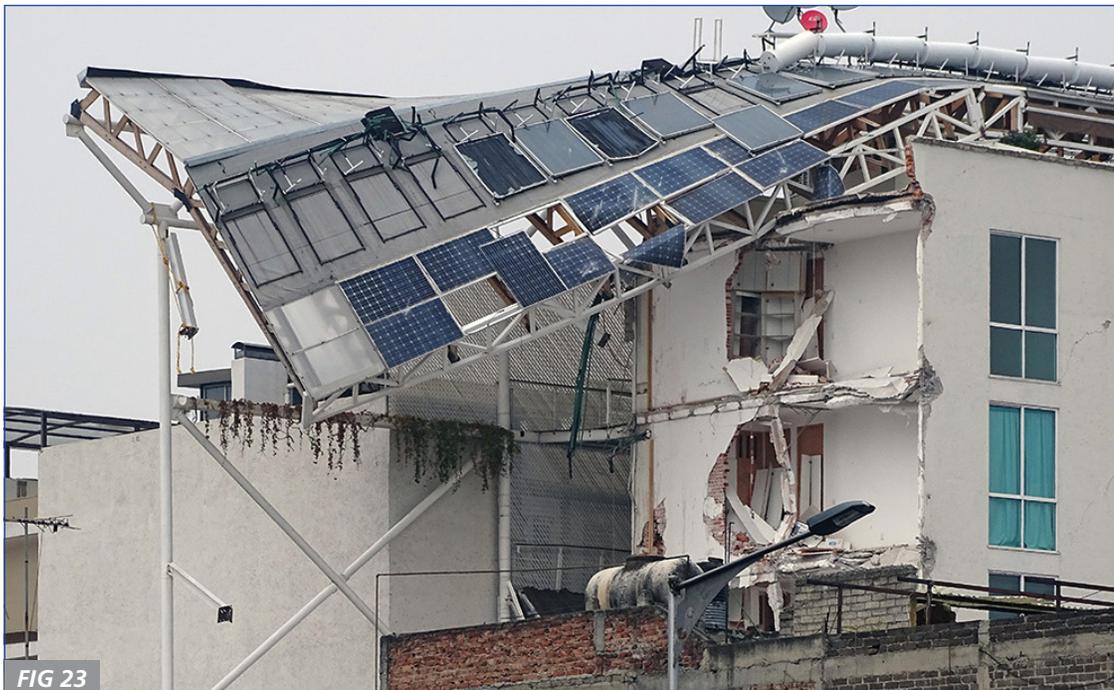
FIG 23

PARTIALLY COLLAPSED BUILDING - The 5-story residential and departmental building suffered a partial collapse. The truss supported roof, distinguished by solar panels, tanks, and satellite dishes, still sheltered the area of the collapse. After the earthquake, an adjacent bridge was shut down to heavy vehicles to prevent further damage to the building through vibration.

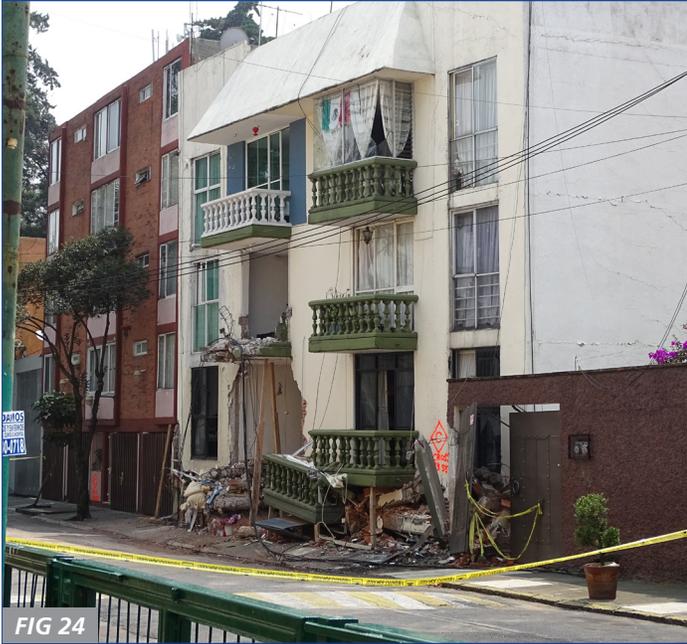
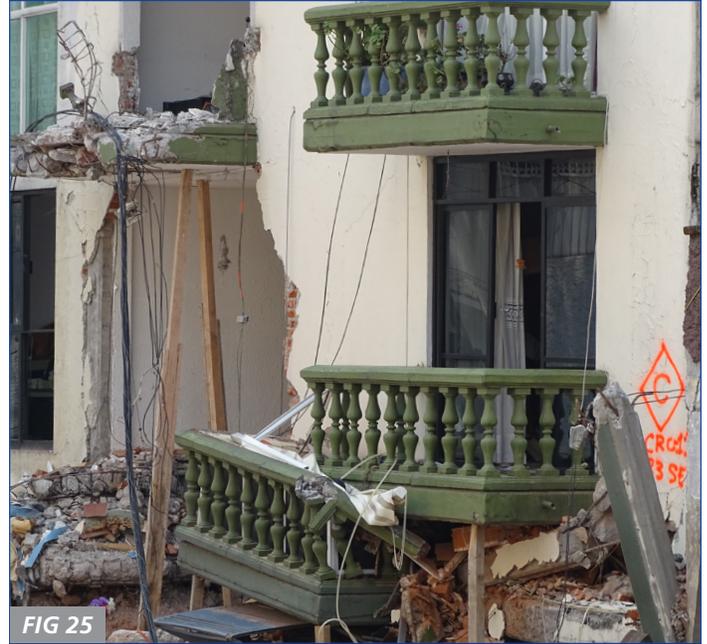
COLLAPSED BUILDING IN BENITO JUAREZ - The 4-story residential building appeared to have incurred multiple failures of the infill masonry out of plane. In addition, the first floor or garage level completely collapsed.

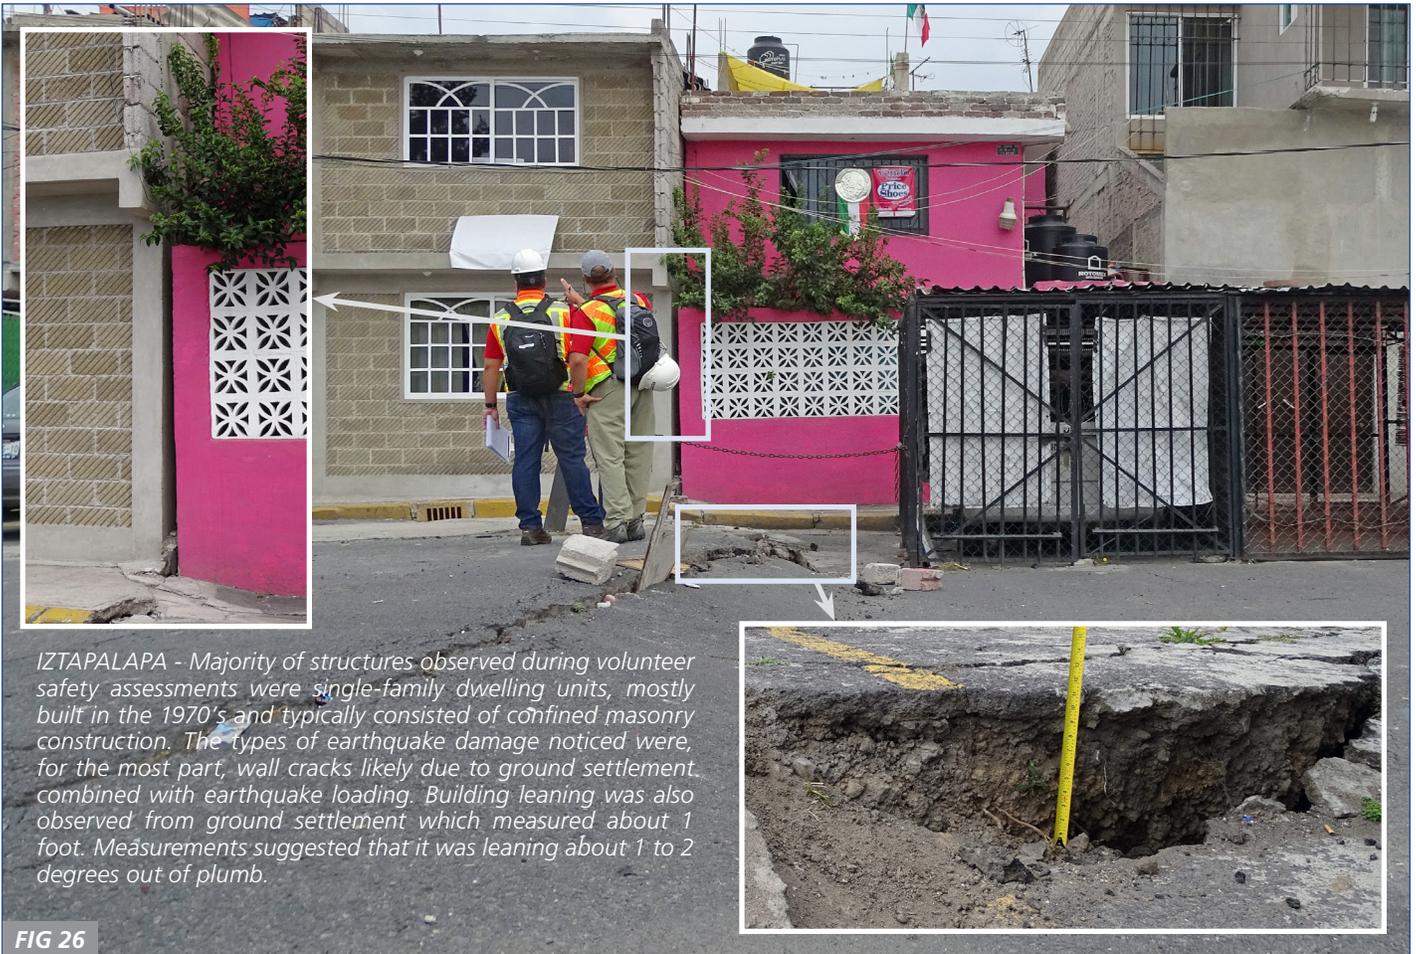
FIG 26

IZTAPALAPA - Majority of structures observed during volunteer safety assessments were single-family dwelling units, mostly built in the 1970's and typically consisted of confined masonry construction. The types of earthquake damage noticed were, for the most part, wall cracks likely due to ground settlement combined with earthquake loading. Building leaning was also observed from ground settlement which measured about 1 foot. Measurements suggested that it was leaning about 1 to 2 degrees out of plumb.

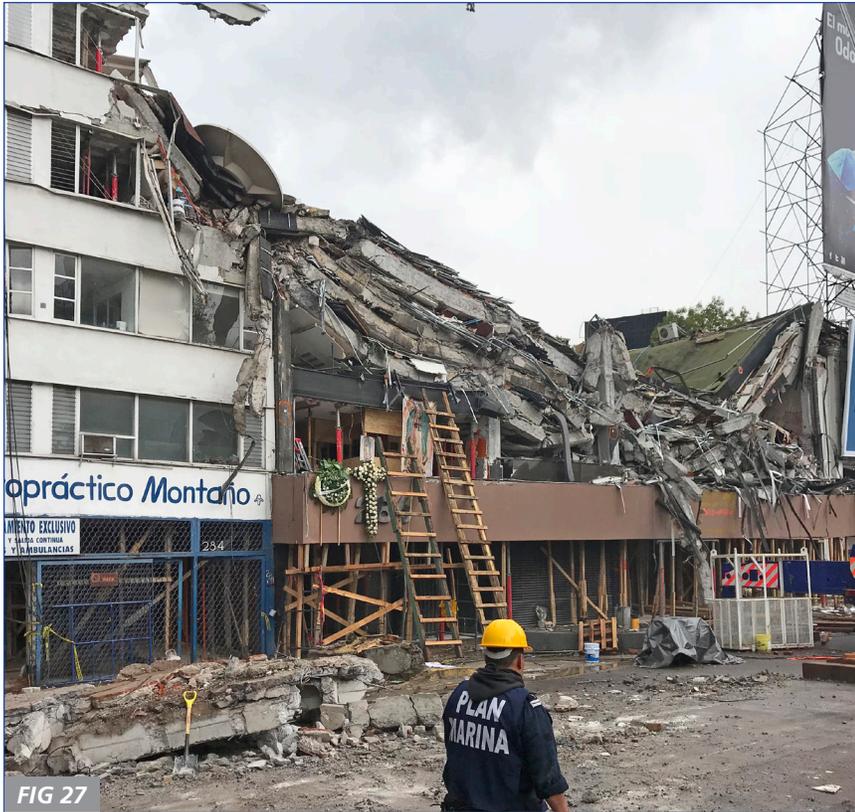
FIG 27

COLLAPSED BUILDING IN CONDESA, CUAUHTÉMOC – Álvaro Obregón 284 & 286 - 5 & 7 story buildings, respectively, were office buildings occupied at the time of the earthquake.

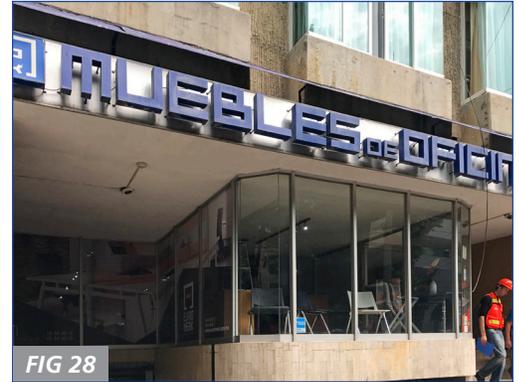
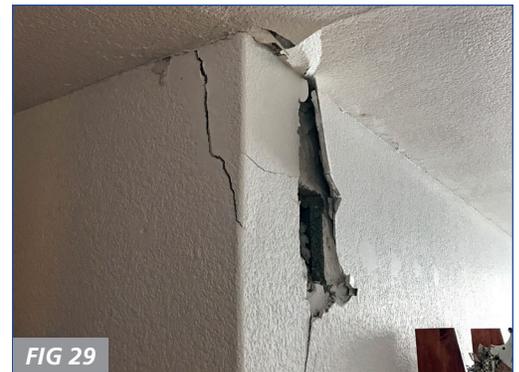
FIG 28

DAMAGED MIXED USE BUILDING IN CONDESA, CUAUHTÉMOC – 5 story & underground parking residential/mixed use building experienced much non-structural damage.

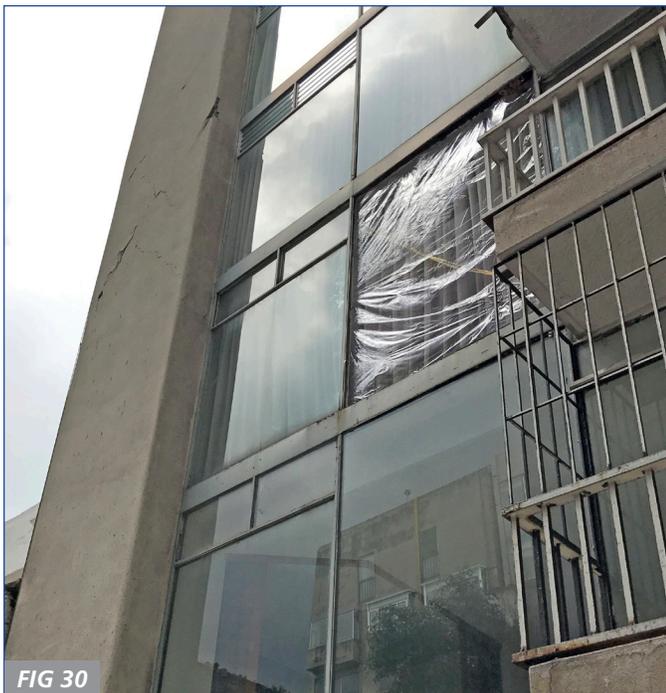
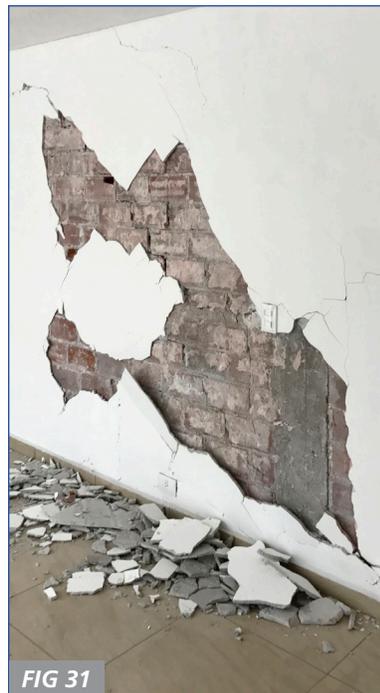
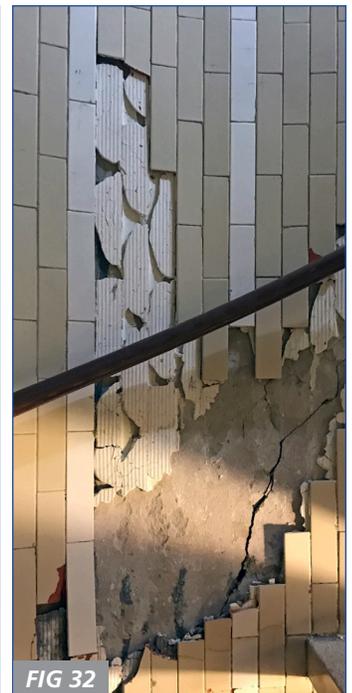
FIG 30

DAMAGED RESIDENTIAL BUILDING IN CONDESA, CUAUHTÉMOC – The 6 story residential building had damage to masonry infill walls. In addition, there was damage to the stairwell.

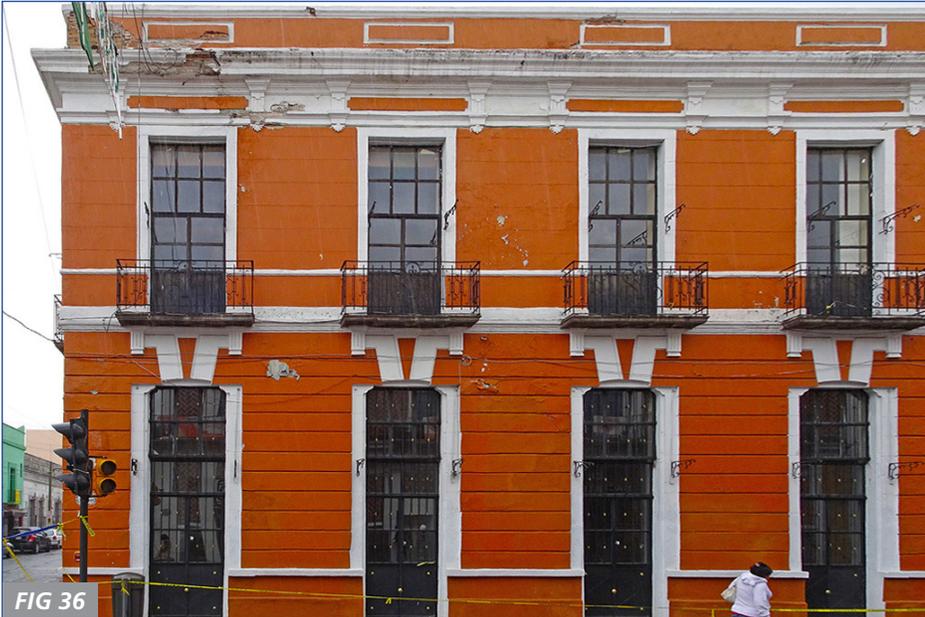
PARAPET DAMAGE - Historic City Center parapet damage to 2-story buildings. This is an example of minimal damaged observed in vulnerable buildings.

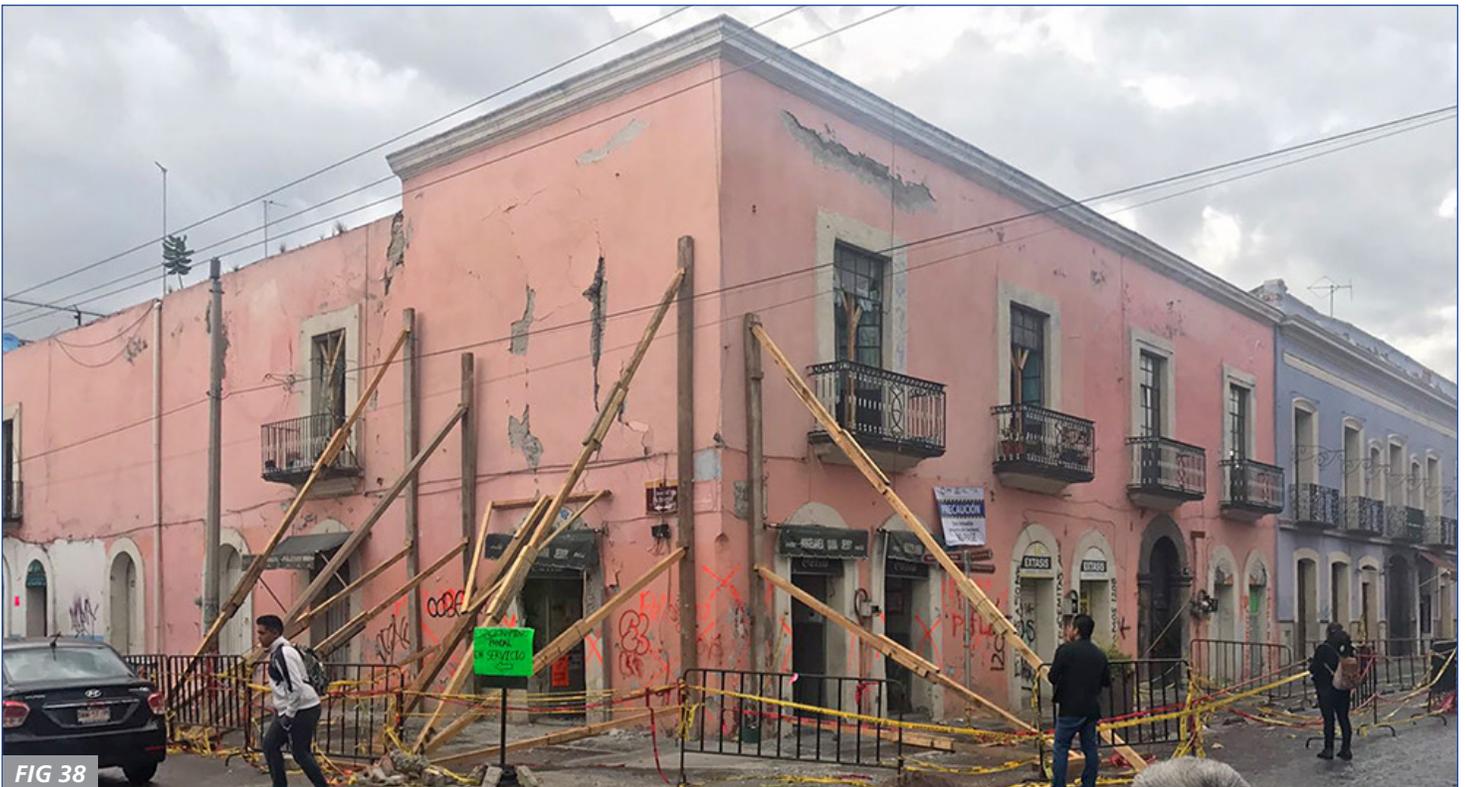
HISTORIC CENTER OF PUEBLA - This 2-story building experienced a commonly observed phenomena in dense, adjoined building construction. One of the few severely damaged buildings in Puebla

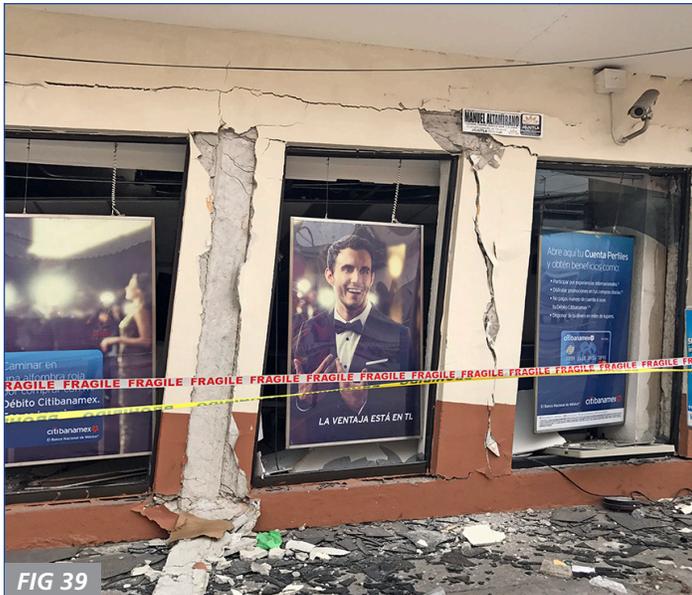
FIG 39

RACKING & NON-DUCTILE COLUMN DAMAGE - Reinforced concrete structure that experienced significant drift - potential soft story

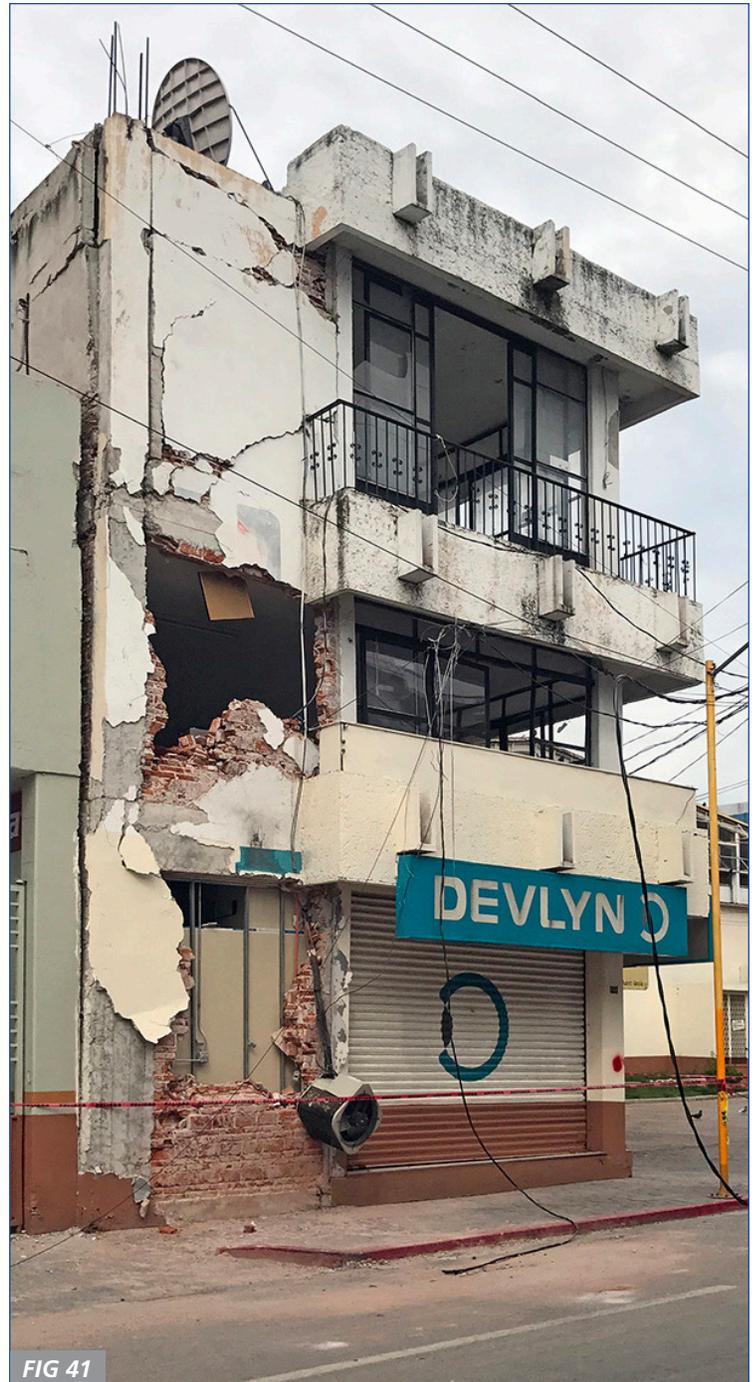
FIG 41

CONFINED MASONRY DAMAGE - Significant damage to confined masonry infill

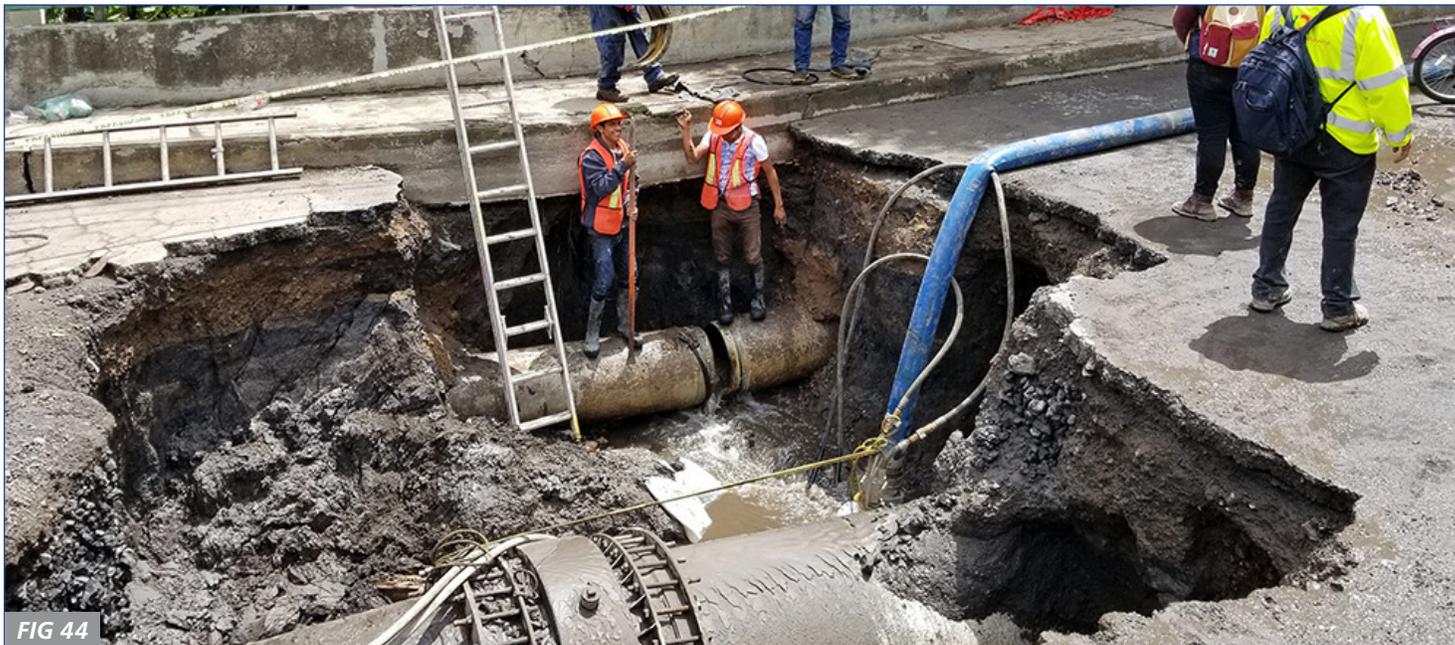
FIG 44

WATER DISTRIBUTION SYSTEMS – Emergency repairs were observed being performed on a 48" diameter main water service line for Mexico City. In addition, as shown in the photo, damage to the adjacent municipal network was observed and being repaired in order to allow for the service line repair. This resulted in frustrated community members based on the expectations that local water service would be restored

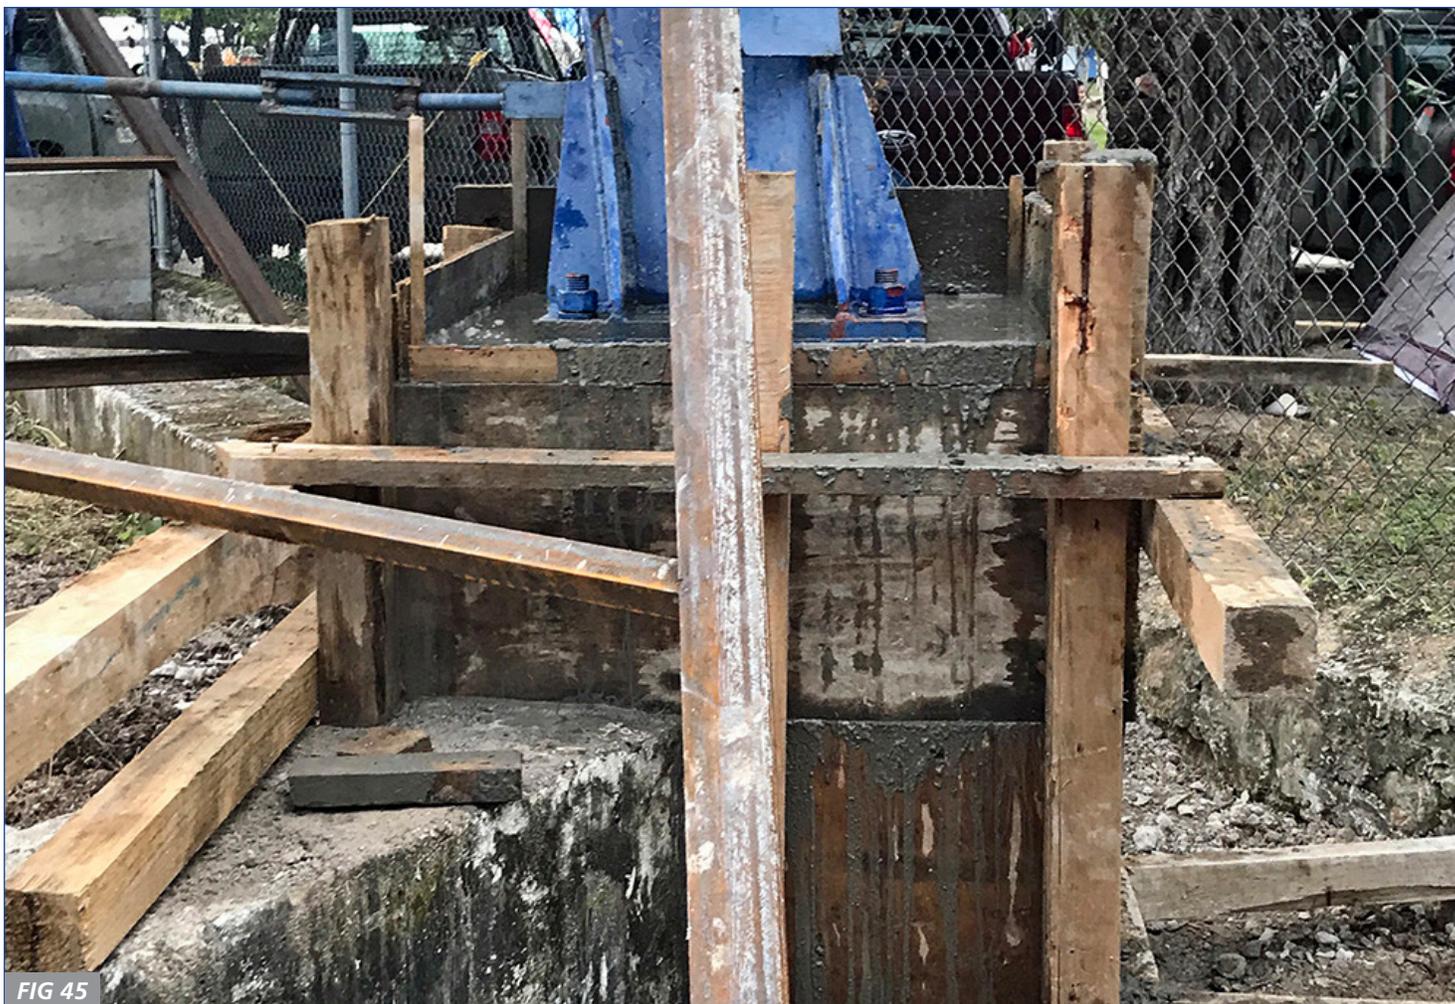
FIG 45

WATER DISTRIBUTION SYSTEMS – Repairs were ongoing to foundation damage at water tank. Steel columns were shored and tank was emptied while reinforced concrete foundations were poured

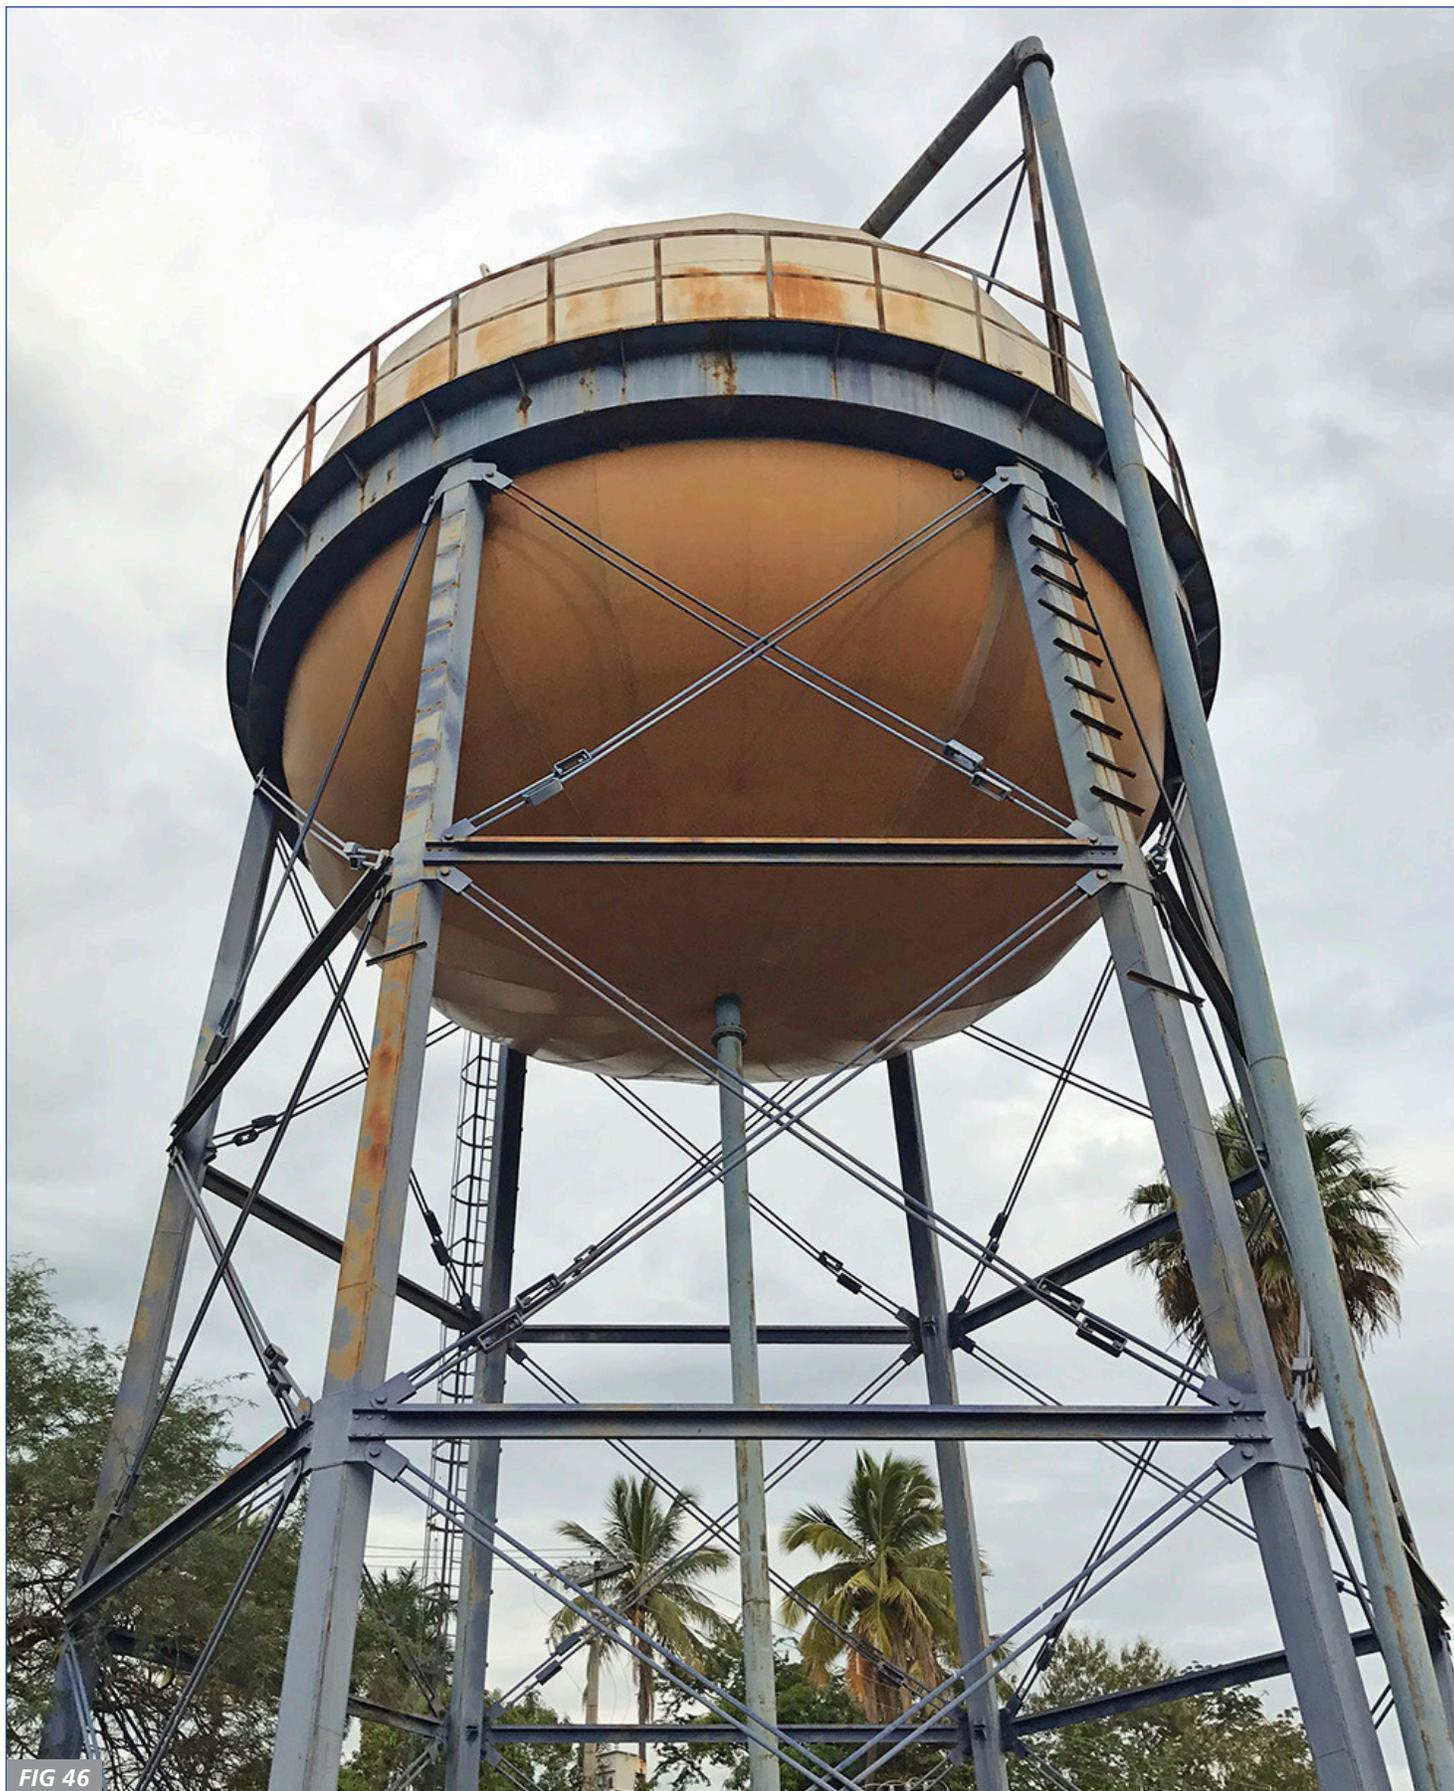
**FIG 46**

WATER DISTRIBUTION SYSTEMS – Steel water distribution tank where bracing rods were observed to be loose from inelastic deformations during the seismic event

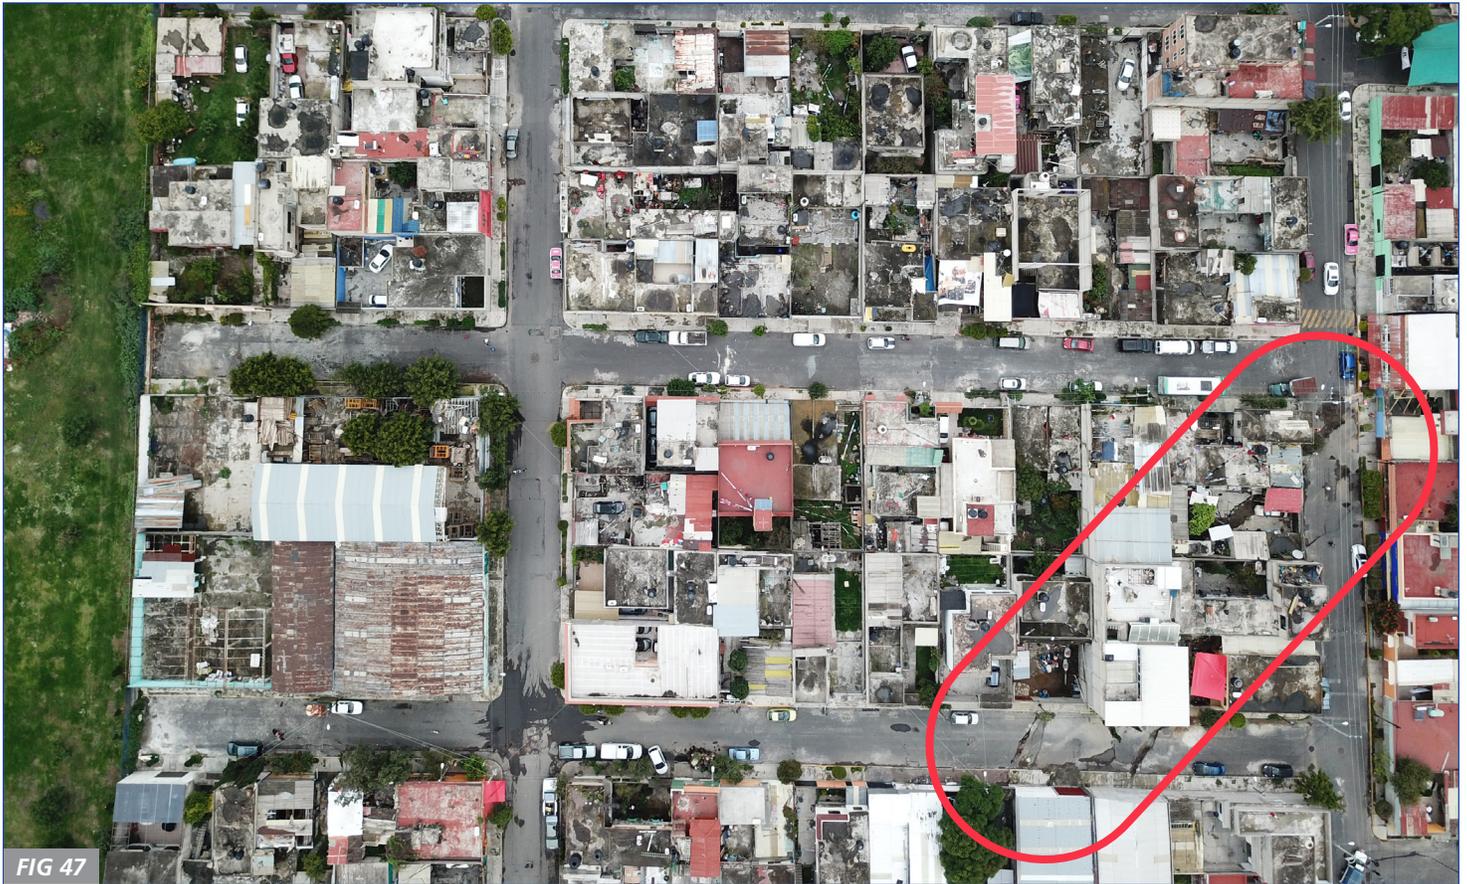
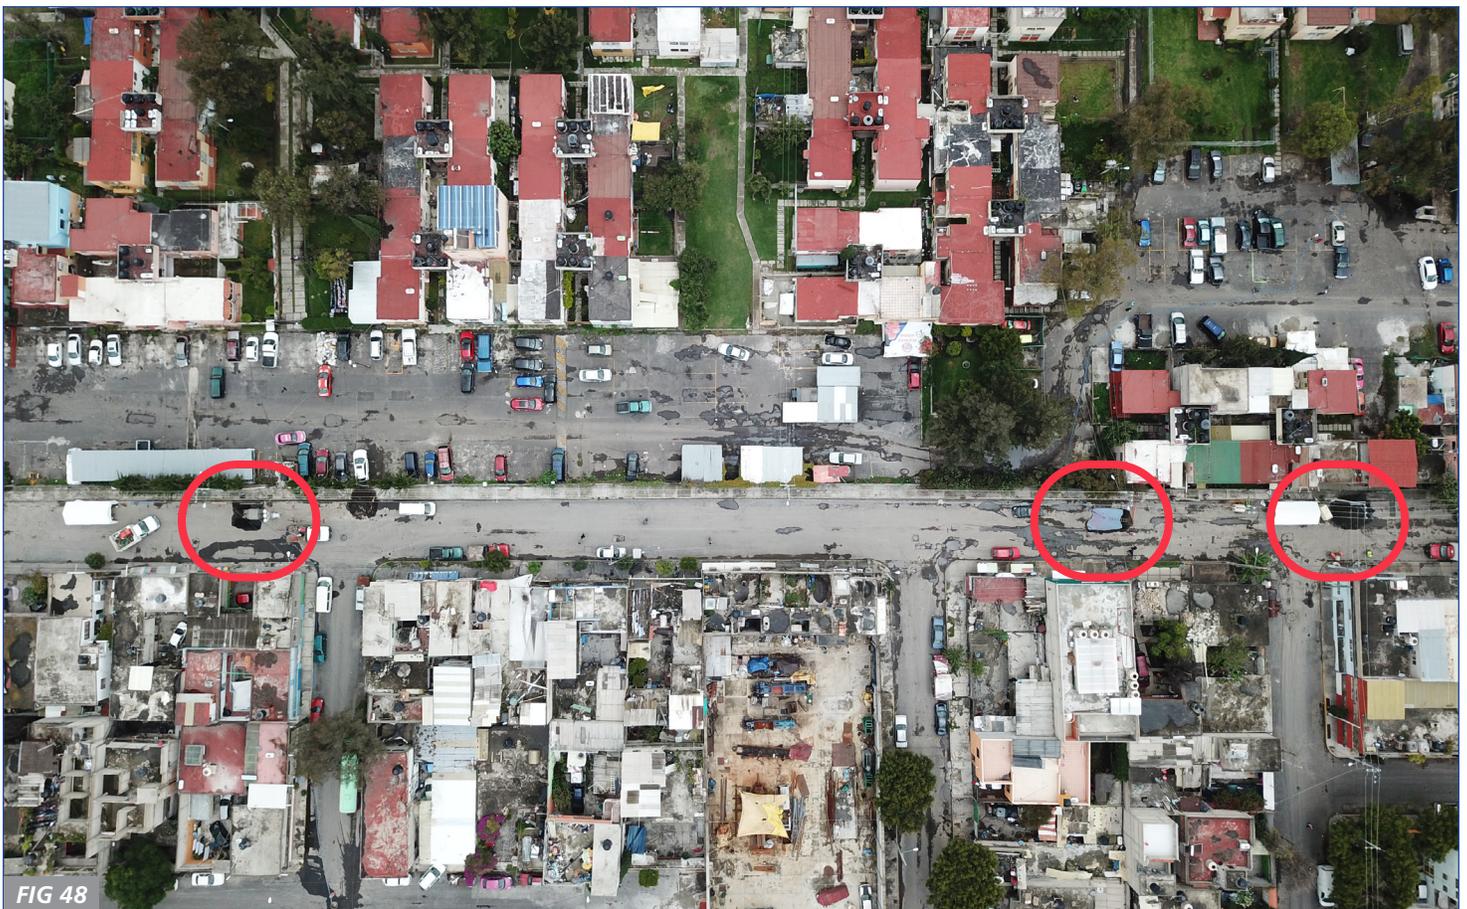
WATER DISTRIBUTION SYSTEMS – Tlahúac water system damage, ongoing repairs to main aqueduct

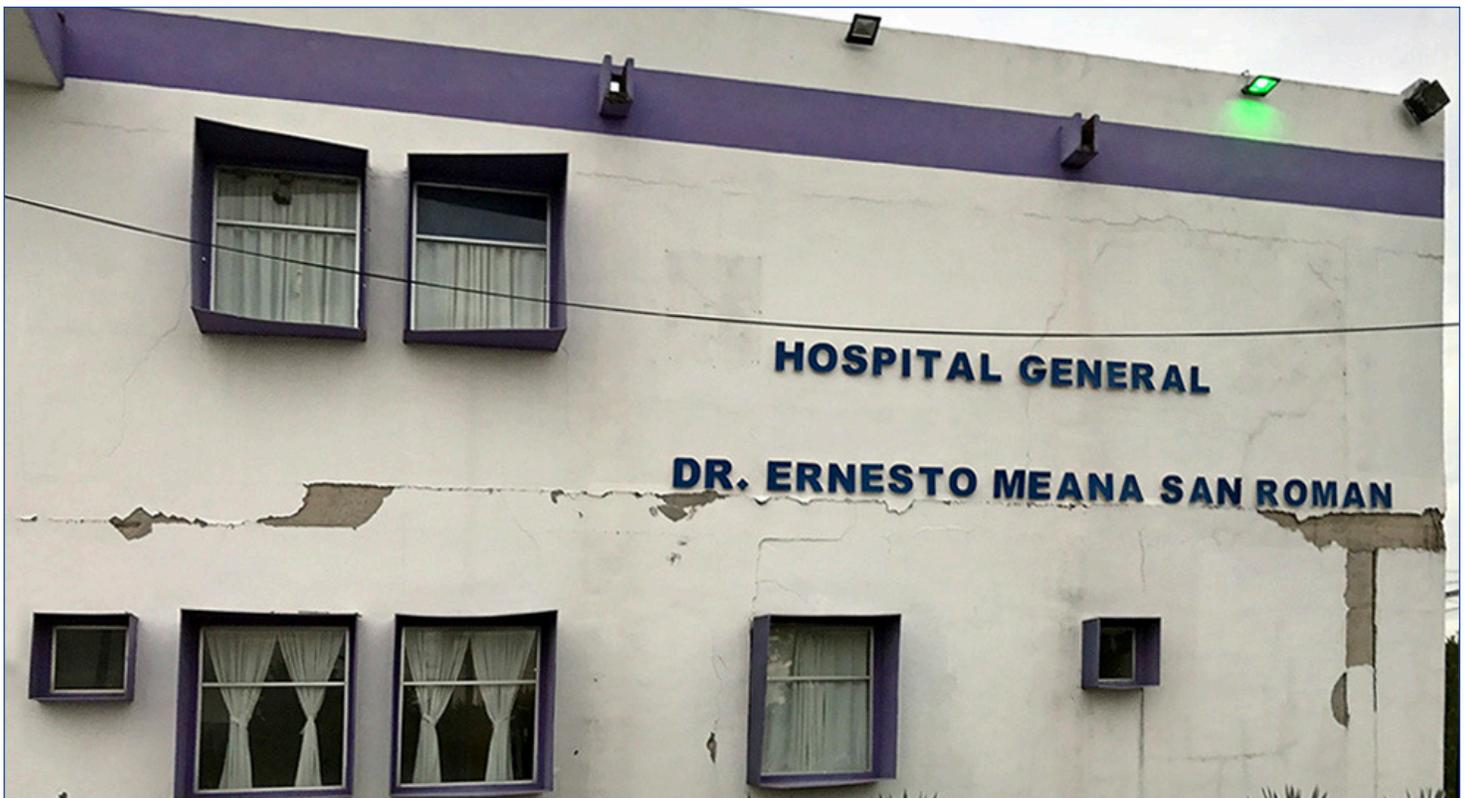
FIG 50 Hospital General Dr. Ernesto Meana San Roman in Jojutla, Morelos suffered structural damage to half of the building but the other half remained operational

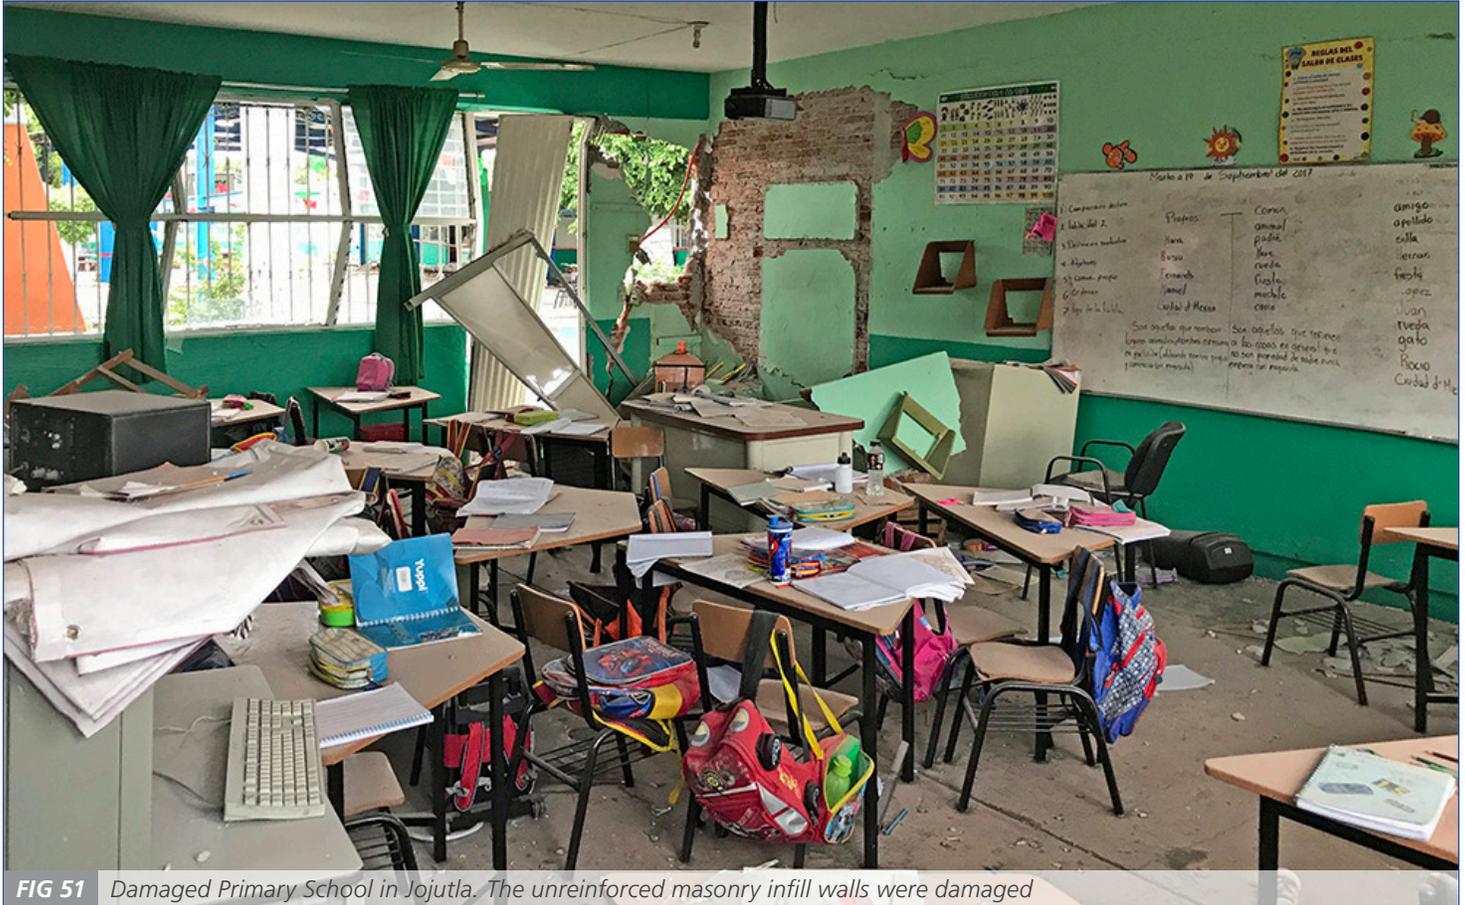
FIG 51 Damaged Primary School in Jojutla. The unreinforced masonry infill walls were damaged

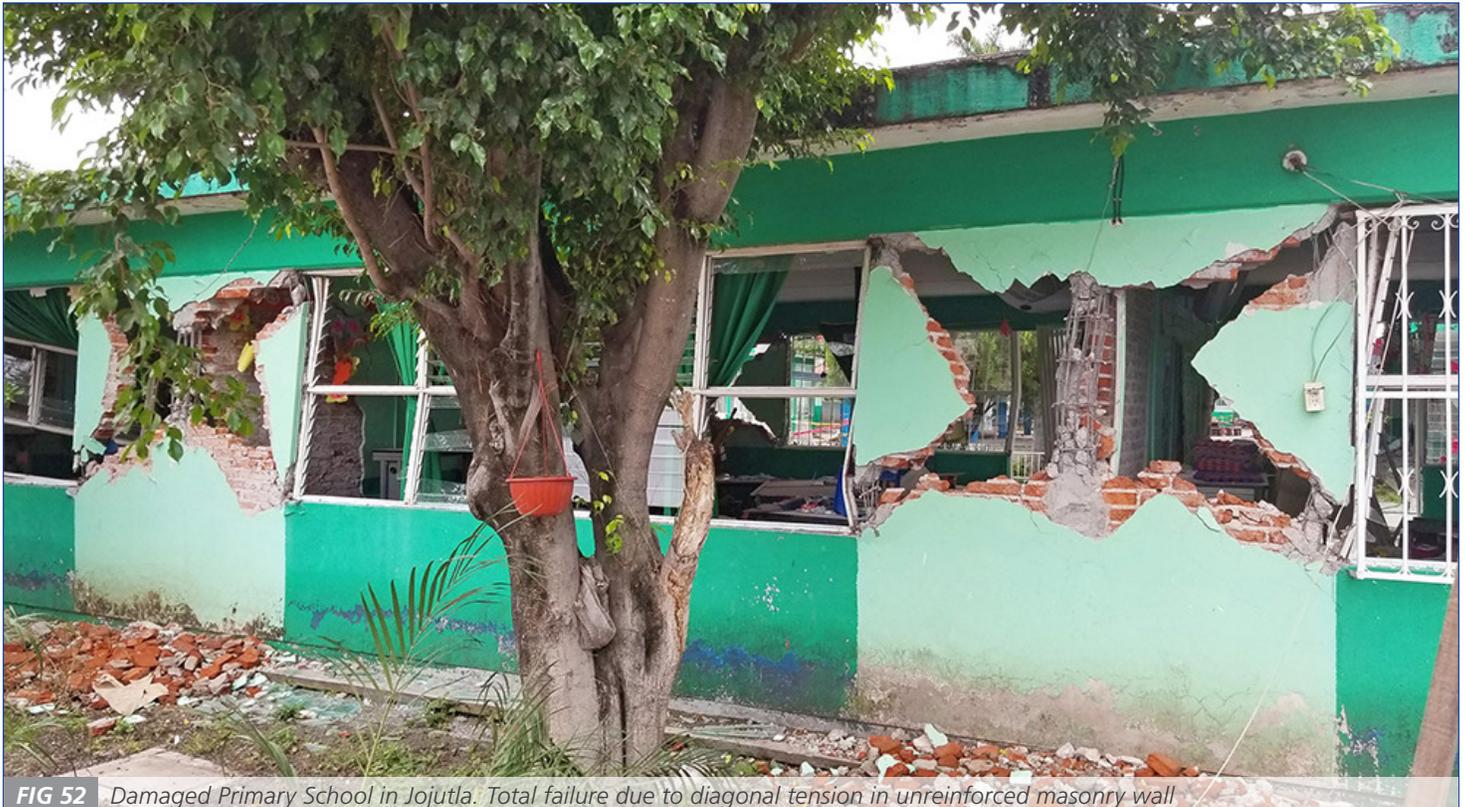
FIG 52 Damaged Primary School in Jojutla. Total failure due to diagonal tension in unreinforced masonry wall
