STRUCTURE

Seismic Repair and Retrofit in Alaska

By Ellen Hamel P.E., S.E.

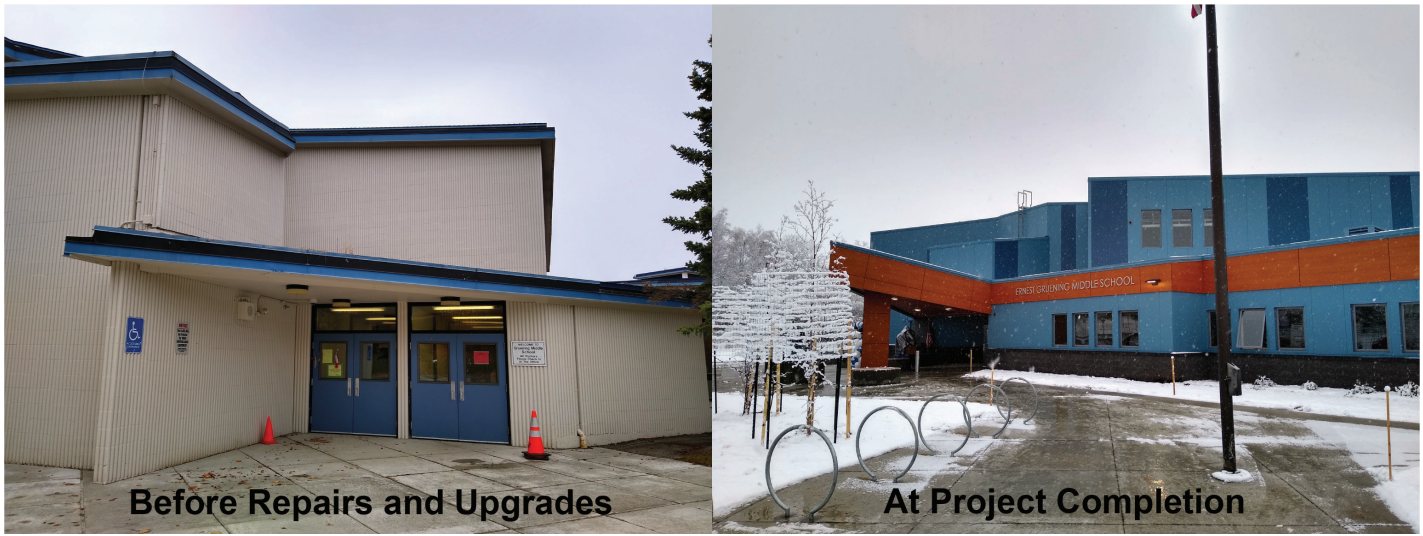
Figure 1. Gruening Entry Before and After

Gruening was originally designed in 1981 as a two-story, approximately 124,000-square-foot building that is X-shaped in plan. The gym and multipurpose room (MPR) are both 2-story spaces that infill the arms of the X. The building is wood framed with both wood shear walls (interior and exterior) and stack bond Concrete Masonry Unit (CMU) shear walls (interior only). The exterior wood shear walls were covered in 5-inch masonry veneer that is identical in appearance to the interior

CMU walls (Figure 1). Foundations are concrete spread footings.

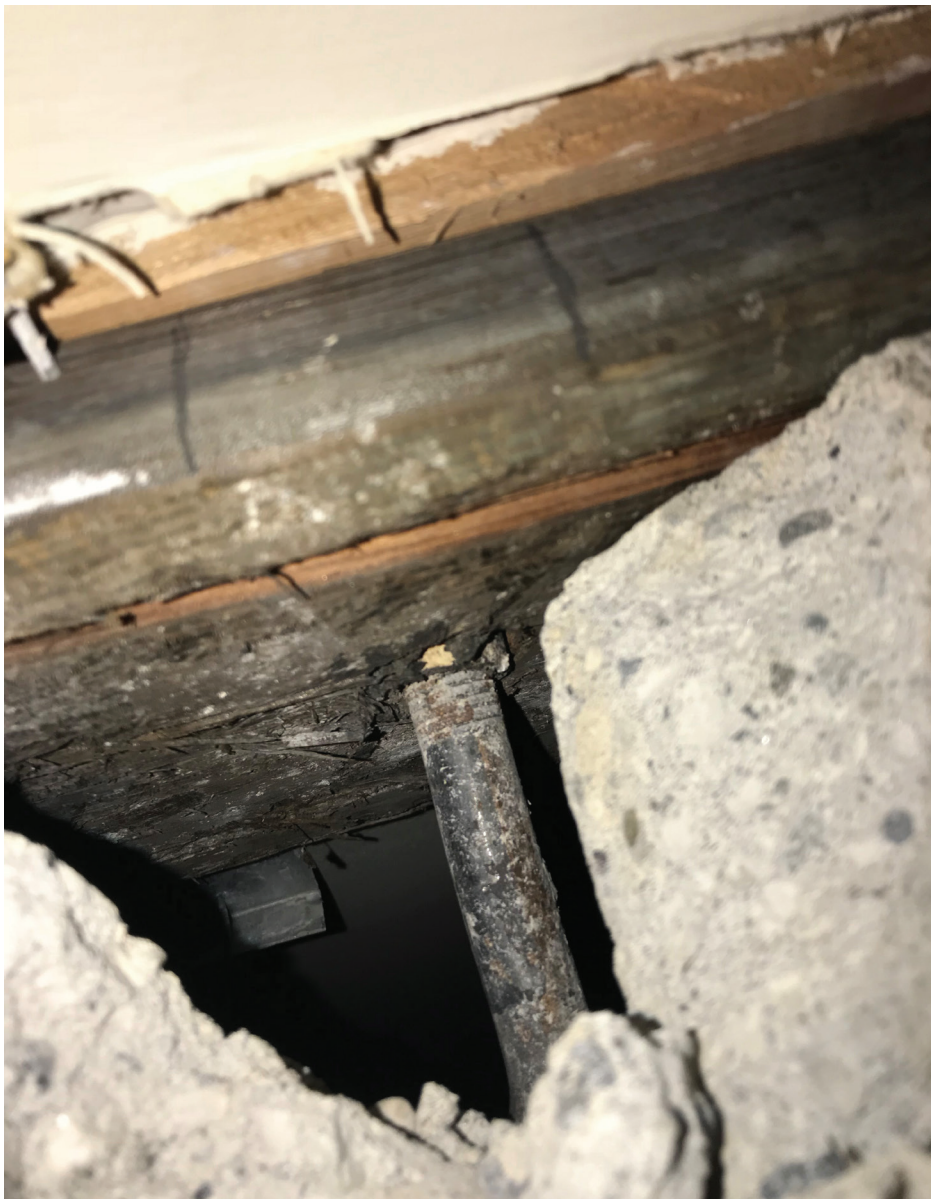
Figure 2. Top of CMU Wall Damage

The most urgent structural earthquake damage at Gruening was the leaning of the two-story CMU wall in the gym. Upon further observation, engineers determined that the top of the CMU wall had detached from the roof diaphragm via splintering of the wood top plate (Figure 2). Detachment occurred along 110 linear feet of wall, and a similar connection existed along 700 linear feet of wall throughout the building.

To repair the damaged top of CMU wall connections, and reduce the risk of failure in future earthquakes, a new connection for the top of the wall had to be developed. The new top-of-wall connection was designed to resist out-of-plane seismic forces per ASCE 7. Engineers designed two different top-of-wall connections to remediate the existing condition: (1) a two-sided connection using steel bent plates on both sides of the wall, and (2) a single-sided connection using a single steel plate on one side of the wall, anchored to the CMU wall using a through-bolt. The engineer, architect, and contractor coordinated throughout the design and construction process to determine which of the two connections would be best suited at each location. Once all

700 feet of new connections were installed, the contractor removed the temporary shoring of the tall gym and MPR walls.

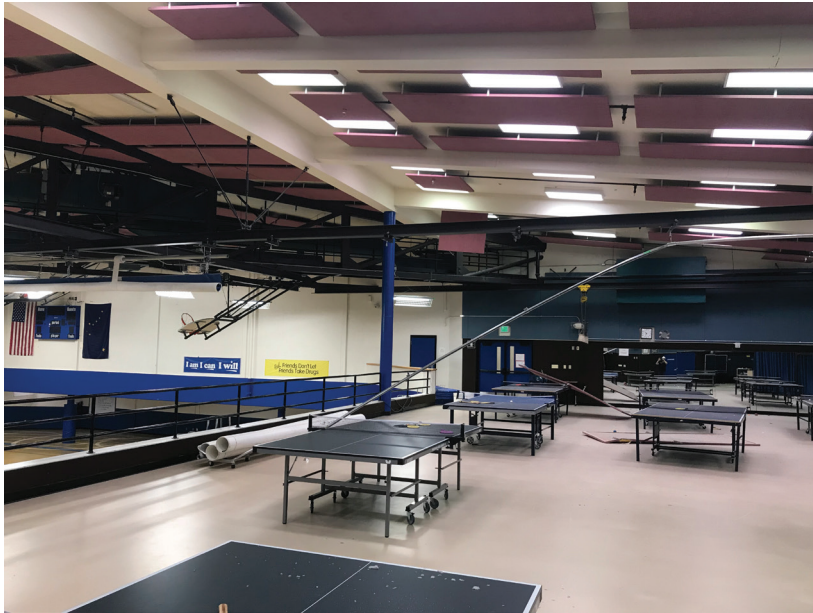
Figure 3. Damaged Curtain Support Beam

In the gym, 40 feet of the curtain support beam was bent during the earthquake (Figure 3). After coordination with Gruening's architect and staff, the contractor removed the damaged portion. As part of the reprogramming of the school, the damaged length of curtain wall support was no longer needed. However, the remaining beam length lacked lateral bracing in the longitudinal direction. Engineers designed an open-channel strut bracing the beam in the longitudinal direction.

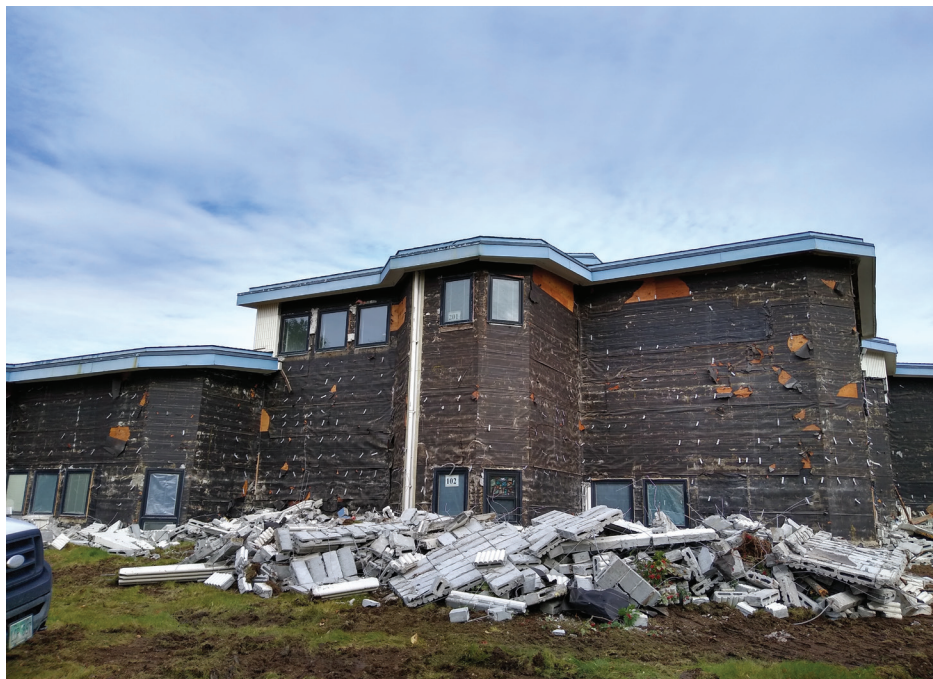
Figure 4. Removal of Masonry Veneer

ASD elected to incorporate voluntary seismic upgrades per ASCE 41 in addition to repairing the earthquake damage. Before beginning ASCE 41 upgrades, engineers, in coordination with the architect, decided to remove the existing masonry veneer from the exterior of the building. This decision was significant because it removed substantial seismic weight from the building, reducing seismic design loads. The existing veneer weight was 63 pounds per square foot; the new siding weight is less than five pounds per square foot; removing the veneer removed 1,200 tons of seismic weight (Figure 4). In addition to reducing weight, removing the masonry veneer and replacing it with a new, lightweight, blue-insulated metal panel siding gave the school a refreshed look. The new look helps to give the public a visual differentiation between the old and new Gruening Middle School.

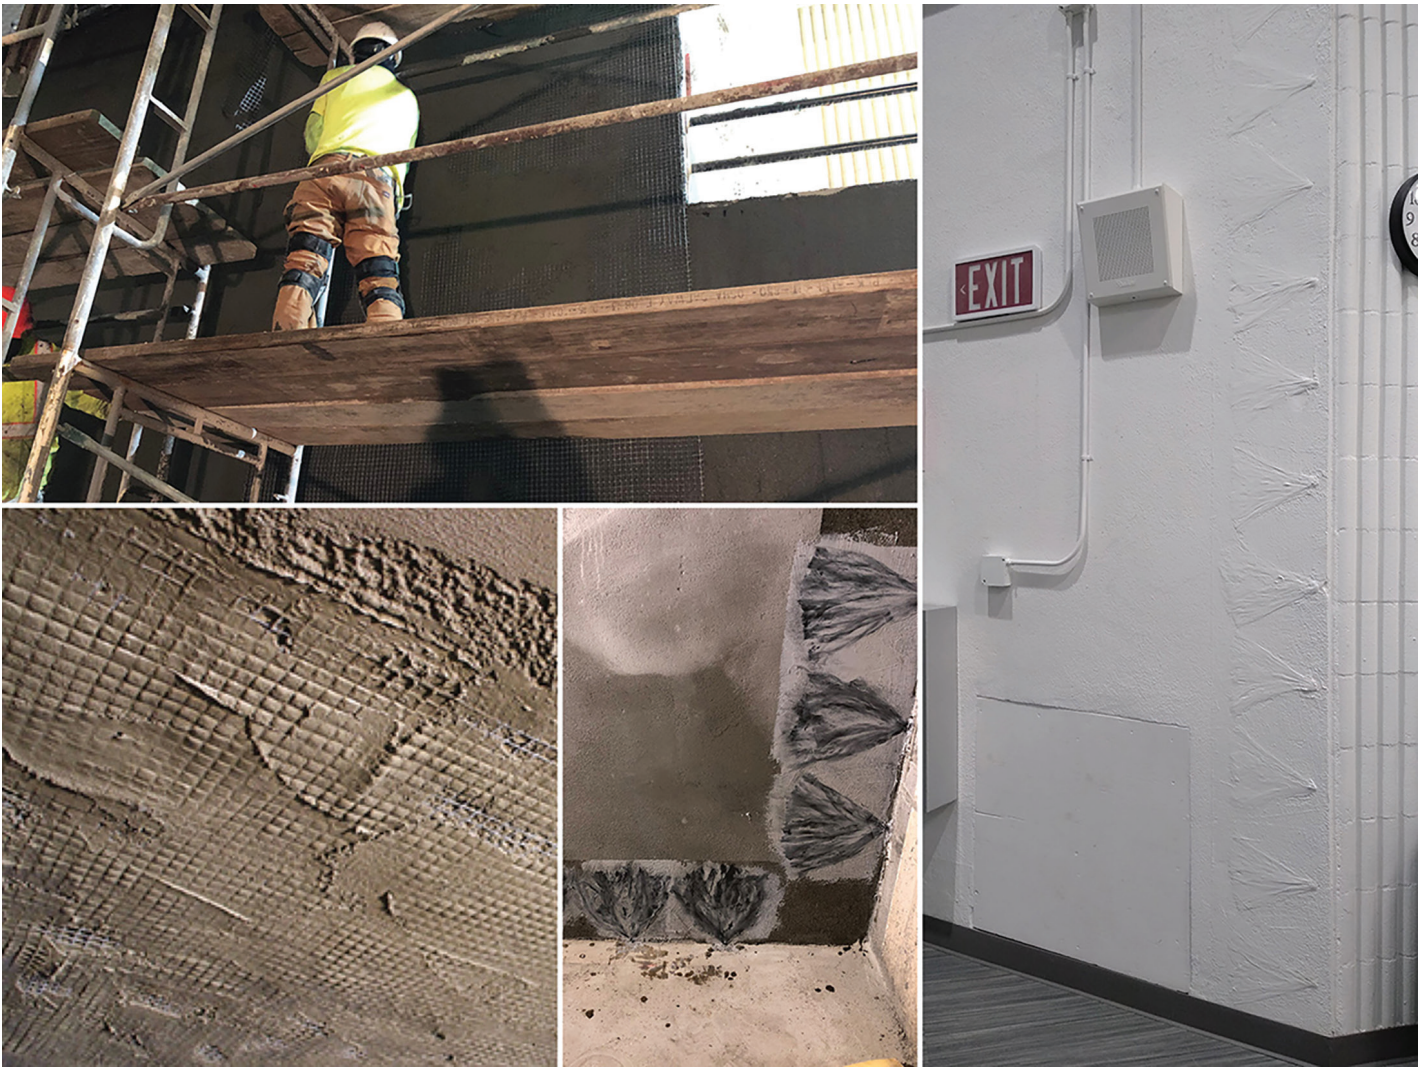
Figure 5. Fabric-Reinforced Cementitious Matrix (FRCM)

inches on-center, current *Masonry Standards Joint Committee (MSJC) Building Code* requirements do not allow 48-inch spacing for stack bond masonry, or for Special Reinforced Masonry Shear Walls, which are required in Seismic Design Category D. Current MSJC code requires a minimum spacing of 24-inch spacing for both vertical and horizontal reinforcement. The spacing of the existing masonry reinforcing at Gruening was 32-inches vertical and 48-inches horizontal; the existing CMU walls at Gruening did not meet the minimum spacing requirements of MSJC. In addition, existing unbraced CMU walls greater than 17 feet high were determined to have insufficient out-of-plane bending capacity.

The FRCM application process was as follows (*Figure 5*):

1. Remove finishes from single (or both) sides of masonry shear walls as noted on plans.
2. Remove paint from the surface.
3. Fill the existing CMU flutes and place the fabric matrix. The anticipated added thickness to the CMU wall is a maximum of ½ inch.
4. Trowel finish and paint as shown on Architectural Drawings.

With close collaboration between the contractor, Simpson, and the engineer, the FRCM installers could place the FRCM ahead of schedule. The installers covered approximately 36,000 square feet of wall with FRCM per the structural drawings. Most of the FRCM was single-sided, except at the tall walls of the MPR, where FRCM was required on both faces of the wall to address deficient out-of-plane bending reinforcing.
