2017 CENTRAL MEXICO EARTHQUAKE RECONNAISSANCE REPORT

On September 19, 2017, at 1:14 p.m. (local time) exactly 32 years to the day after the tragic M8.0 1985 earthquake, central Mexico was struck by a M7.1¹ intraplate earthquake (Fig. 1). It struck only two hours after a citywide earthquake drill and put a dramatic end to commemoration activities taking place throughout the city. This was the second earthquake in a matter of weeks – an M8.1 earthquake located in the Chiapas Region, approximately 467 miles from Mexico City, had struck on September 7. As a result of normal faulting at

Earthquake Reconnaissance Overview

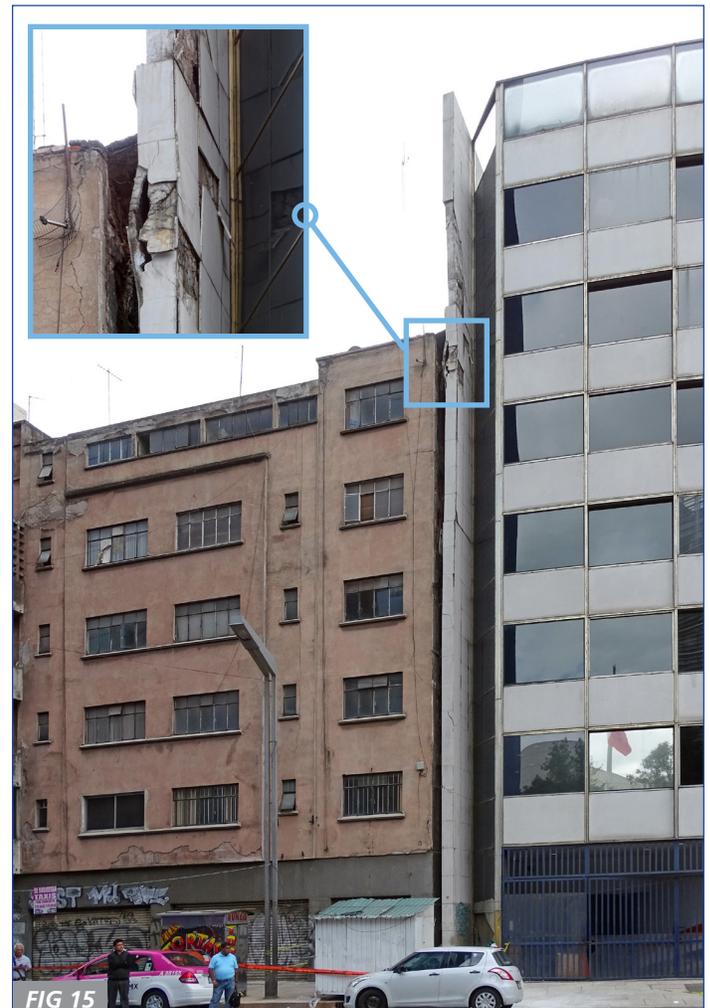
In rural and historic areas, separation between adjacent buildings appeared minimal. Potential falling hazards and damage which may have been due to building pounding or insufficient building separation was observed in damaged buildings (Fig. 15). The minimum building separation requirement of U.S. codes is the square root of the sum of the squares (SRSS) of the inelastic displacement of adjacent buildings. Mexico's building code requires a minimum setback distance of the lesser of 50 mm or a distance equal to the design horizontal displacement increased by a percentage of the floor height. Adjacent buildings should be separated by the sum of the setback distance for both buildings.

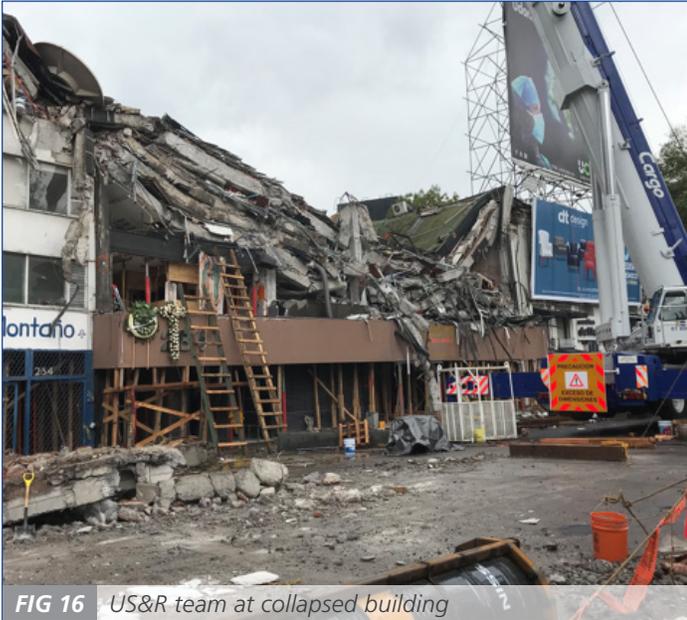
FIG 16 US&R team at collapsed building

Not only did the team volunteer to perform building evaluations, David Swanson (a member of FEMA's Urban Search & Rescue (US&R) Washington Task Force (WA-TF-1)) was able to provide structural engineering guidance at the search and rescue efforts at a collapsed office building in Condesa, Alvaro Obrégón 284/286 (Figs. 16 & 18).

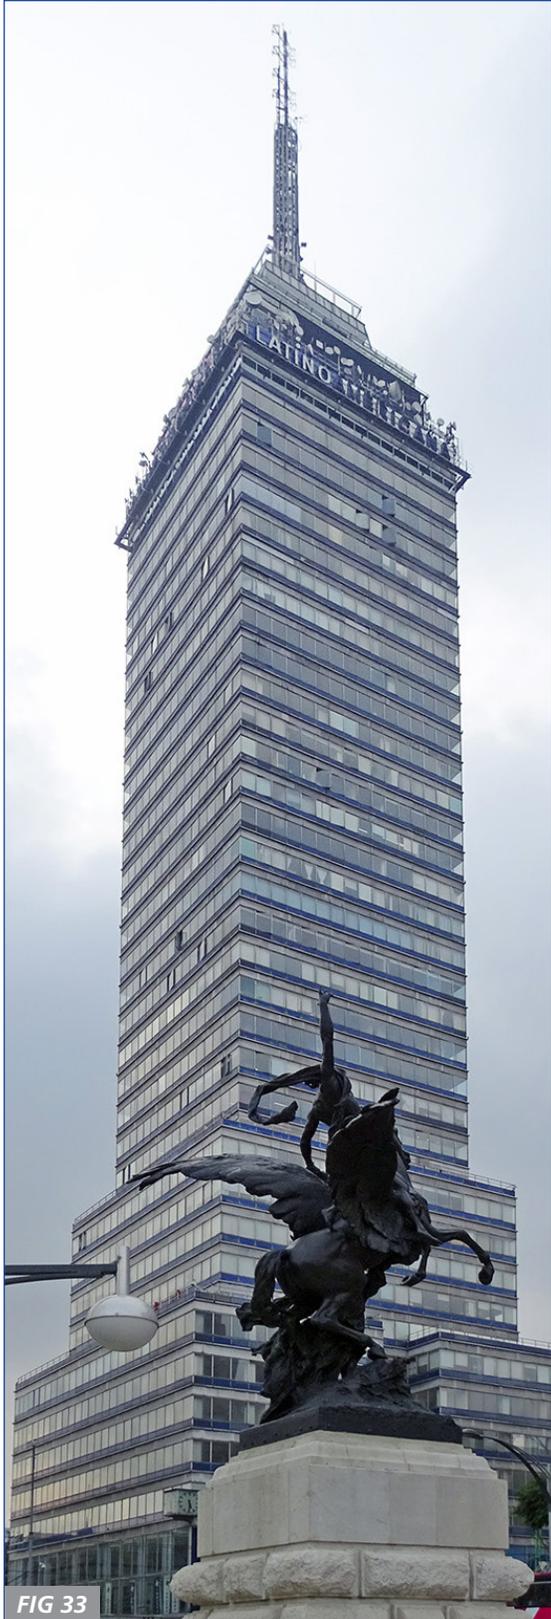
FIG 33

DOWNTOWN MEXICO CITY - The 1956 Torre Latinoamericana Tower, which was the first major skyscraper successfully built in a high-seismic area and had survived the 1985 earthquake undamaged, did not appear to have sustained major damage.¹²

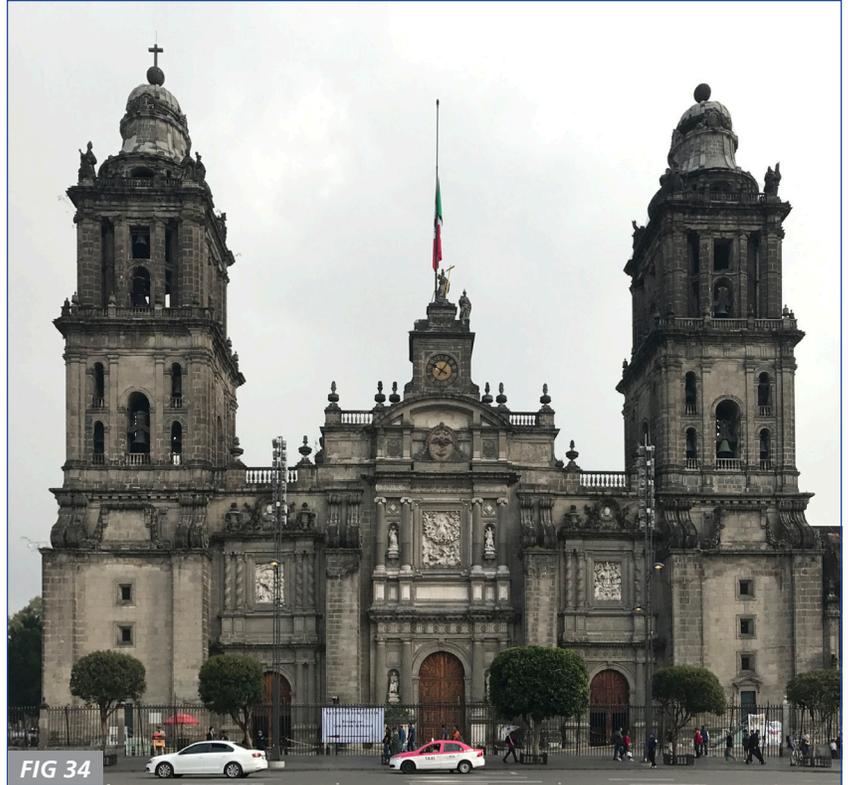
FIG 34

HISTORIC CENTER OF MEXICO CITY - The Cathedral Metropolitana, which is the oldest and largest cathedral in Latin America, survived the 1985 earthquake and was retrofitted. The cathedral still stood and did not appear to have suffered major damage.¹³

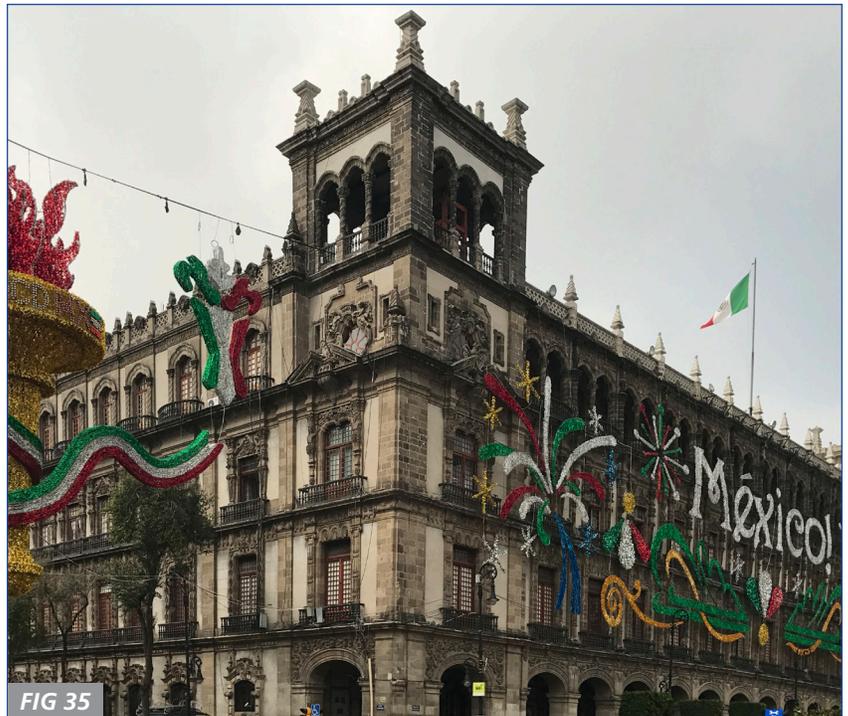
FIG 35

HISTORIC CENTER OF MEXICO CITY - It was noted that very few of the buildings in the area of the Historic Center of Mexico City had observable exterior structural damage. All of the structures were being used as their typical occupancy type, and it remained fully operational.

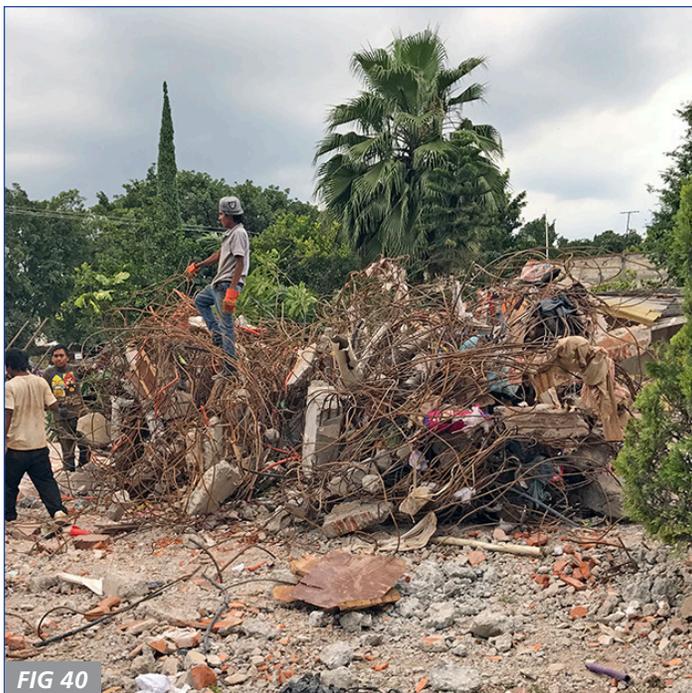
FIG 40

REBAR PILE FOR SCRAPPING - Ongoing demolition and cleanup at site of collapsed buildings

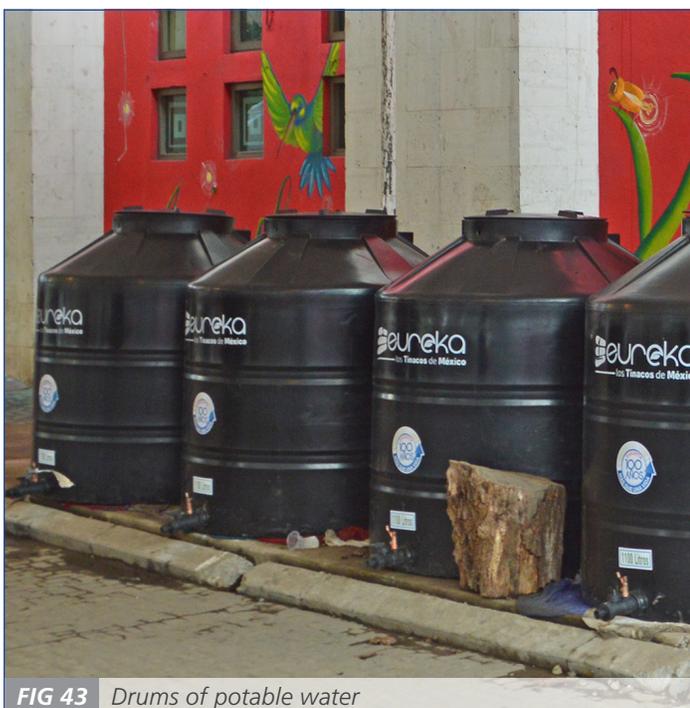
FIG 43 Drums of potable water

As a result of the event, several transmission pipelines were damaged, and many communities did not have access to water service a week after the event. Often, these communities were in less affluent and less influential areas of CDMX. Municipalities and water service providers distributed large drums of potable water throughout communities and returned on regular cycles to refill the drums. The drums were strategically placed within walking distance for most community residents (Fig. 43).

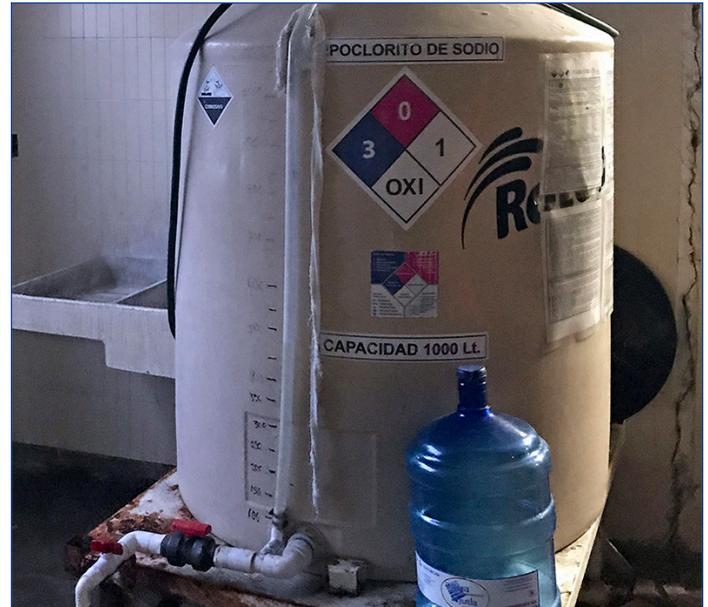
FIG 49 Chlorine tank essential for hospital housekeeping operations at Hospital General Dr. Ernesto Meana San Roman

HEALTHCARE SYSTEM: Several hospitals sustained nonstructural damage, loss of water service (ostensibly), and minor structural damage. Local newspapers reported that the operations of 600+ healthcare facilities were affected on some level, including clinics, hospitals, and medical office buildings. However, there were no reports of hospitals that suffered extreme structural damage or collapse.
