What can Seattle area learn from Mexico City's quake experience?

■ Two teams led by Reid Middleton traveled to Mexico to see how different types of structures performed during the recent temblor.

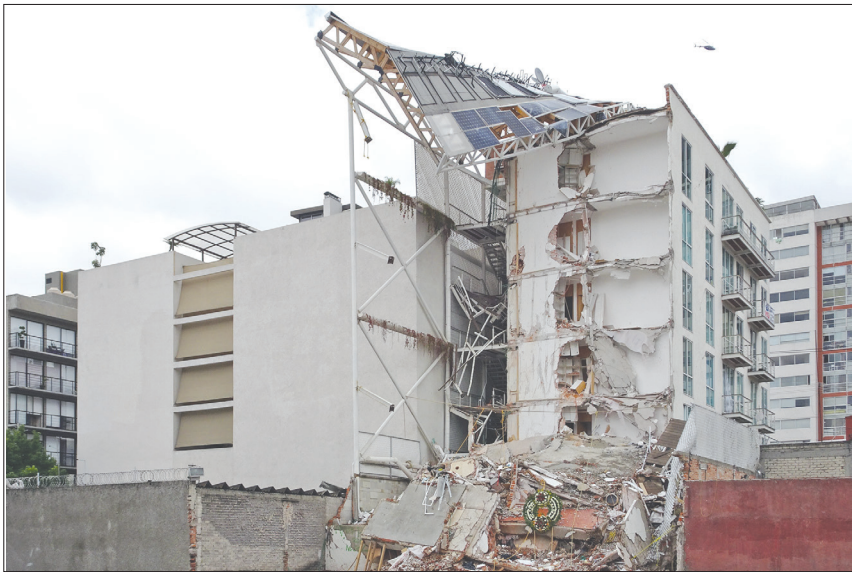
Part of this apartment building in Mexico City collapsed in the quake. An adjacent bridge was closed to prevent vibrations from further damaging the structure.

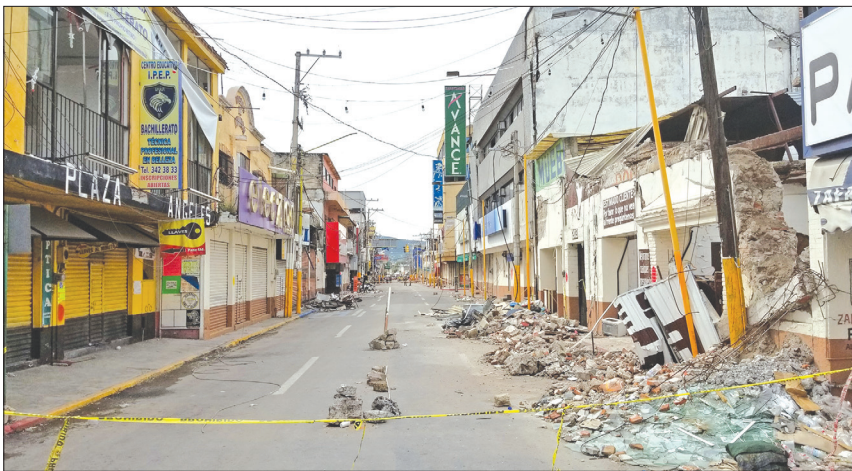
Damage was extensive on this main street in Jojutla, south of Mexico City.
